THE WATERFORD MILL  
*Waterford, Virginia*

HISTORIC STRUCTURE REPORT

24 May 2013

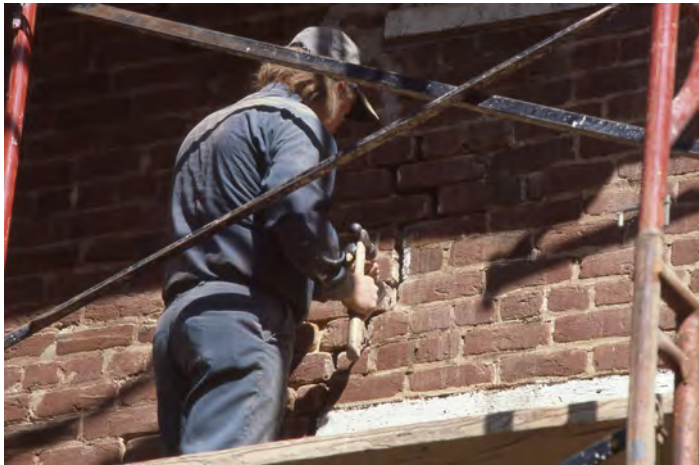
Removing portland cement repairs, south wall, April 1984 [WF slide collection]

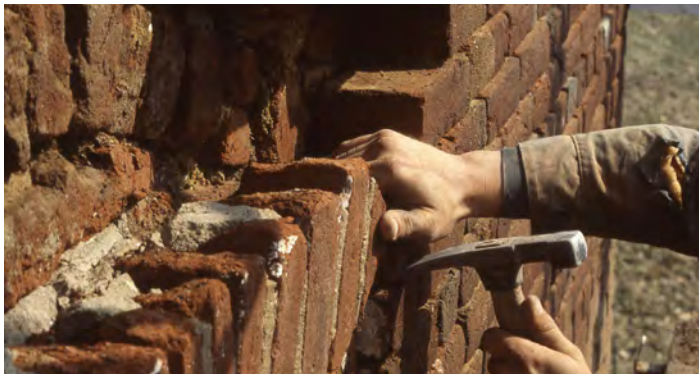
Third-floor jack arch under repair, March 1984 [WF slide collection]

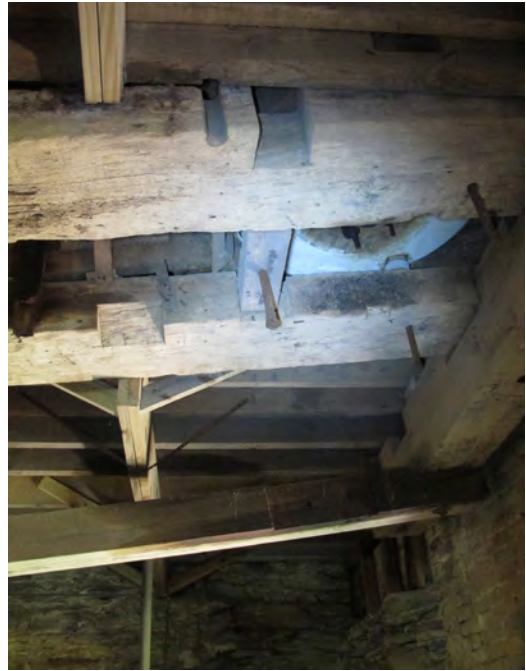
Right: Eastern millstones shifted to the south on original stone bearers.

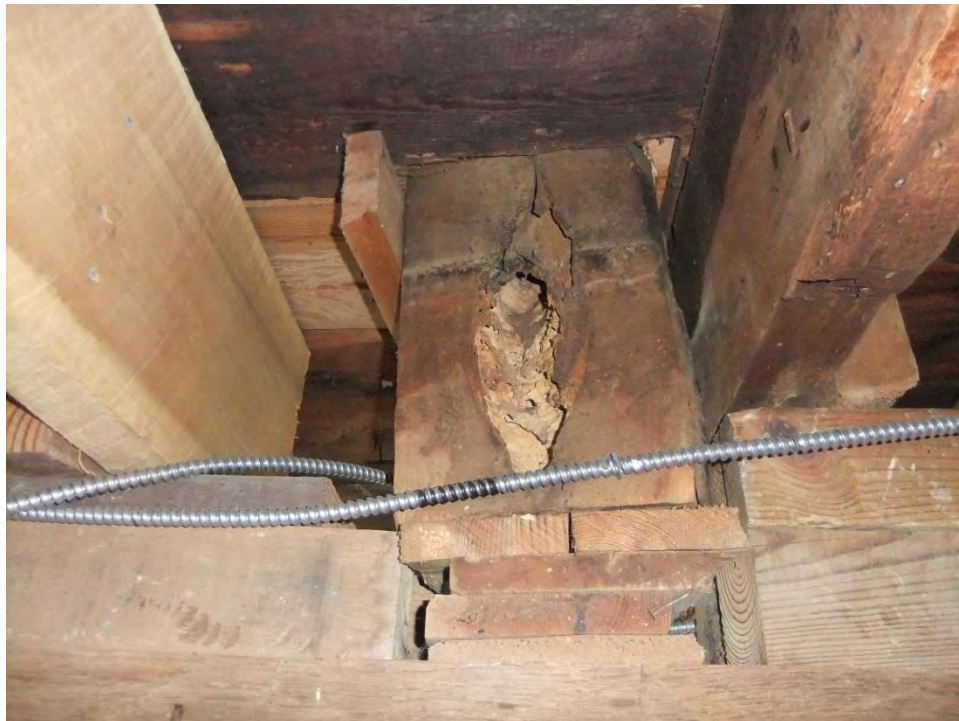
**Figure 20:** Third floor post deterioration

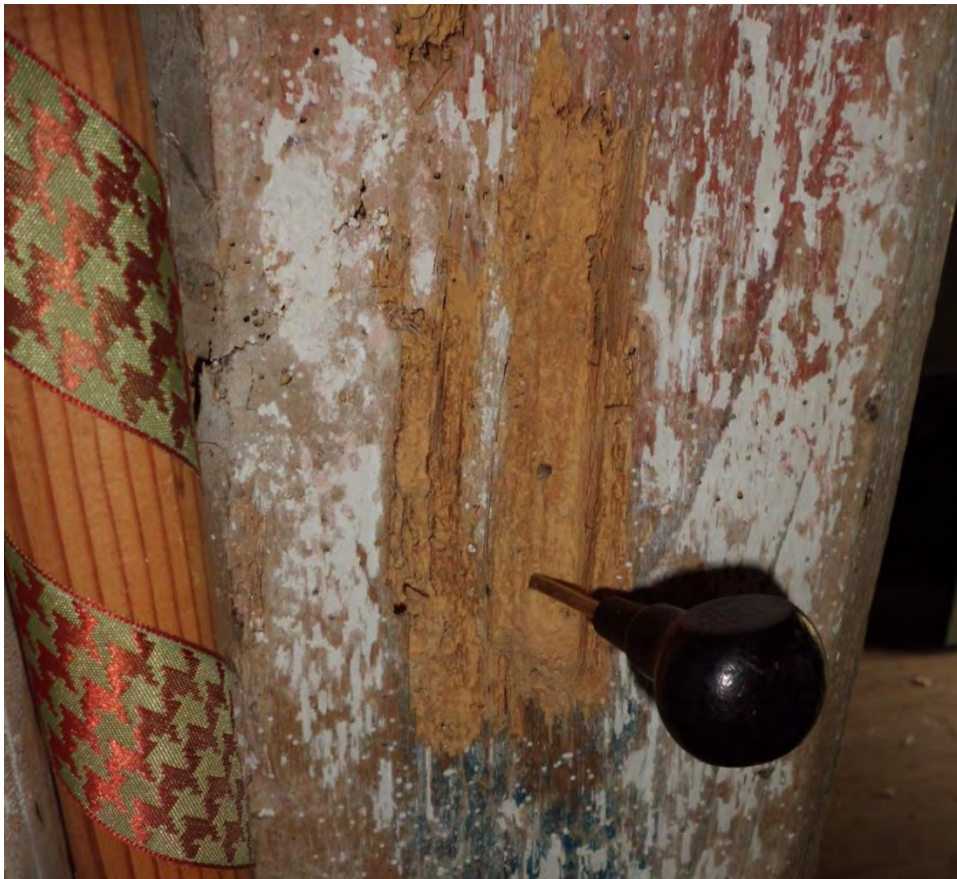
**Figure 26:** Second floor southeast corner column deterioration

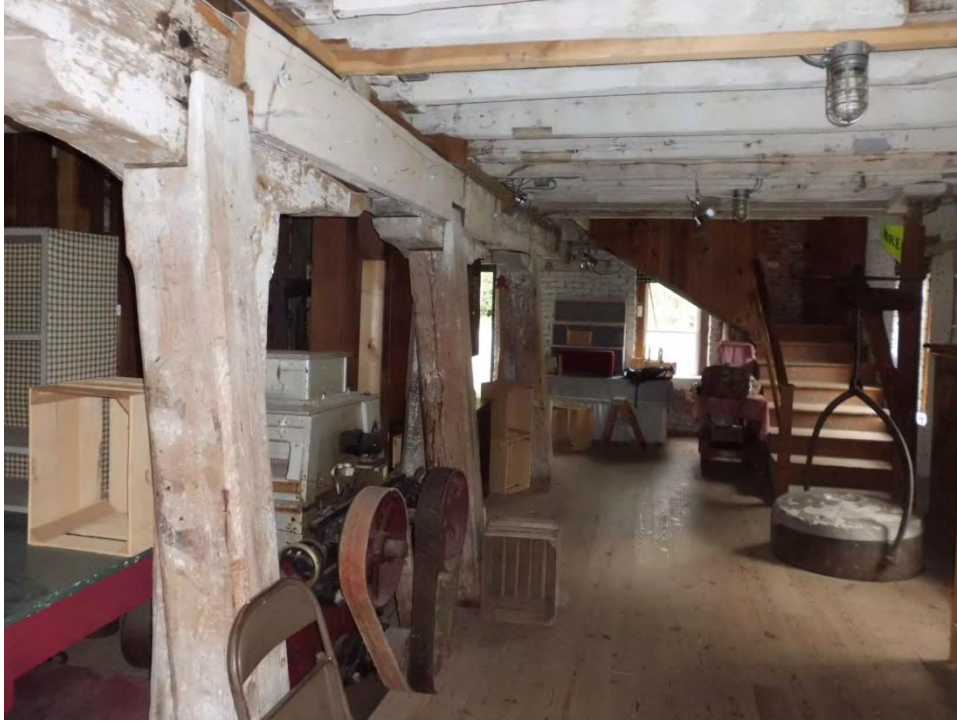
**Figure 27:** Second floor canted column brace

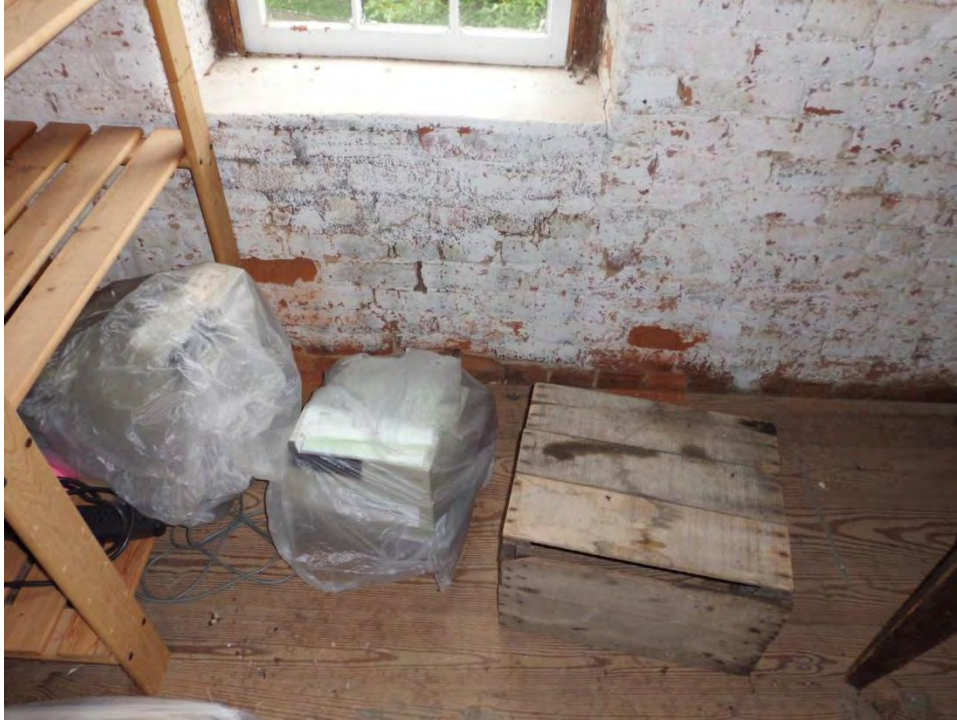
**Figure 29:** Spalling of masonry below first floor window opening along south wall

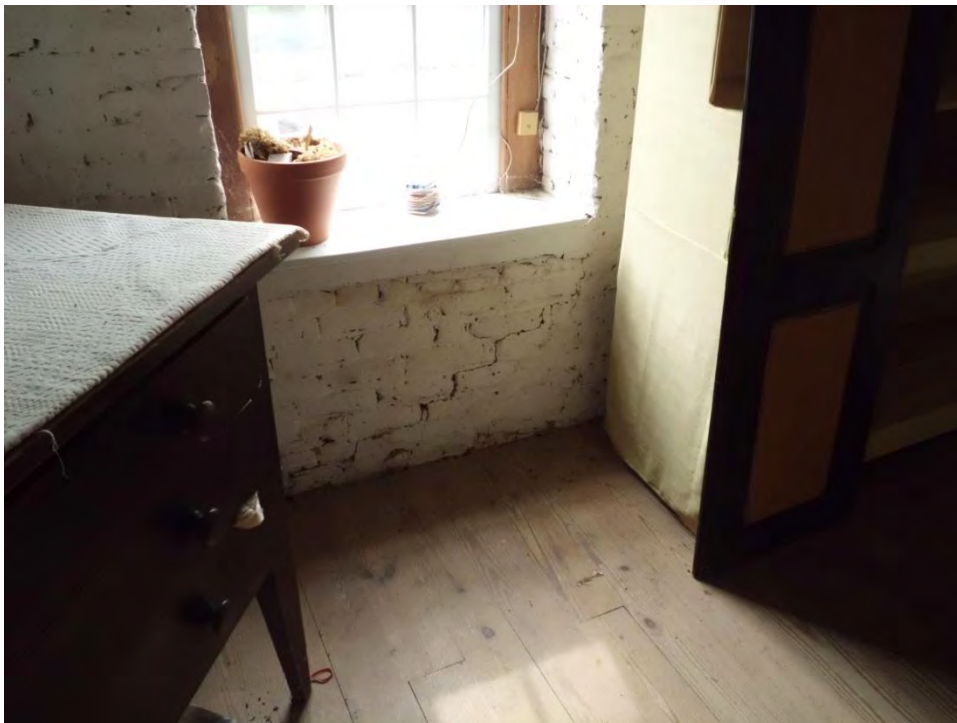
**Figure 30:** Diagonal cracking within mortar joints below first floor window opening along west wall

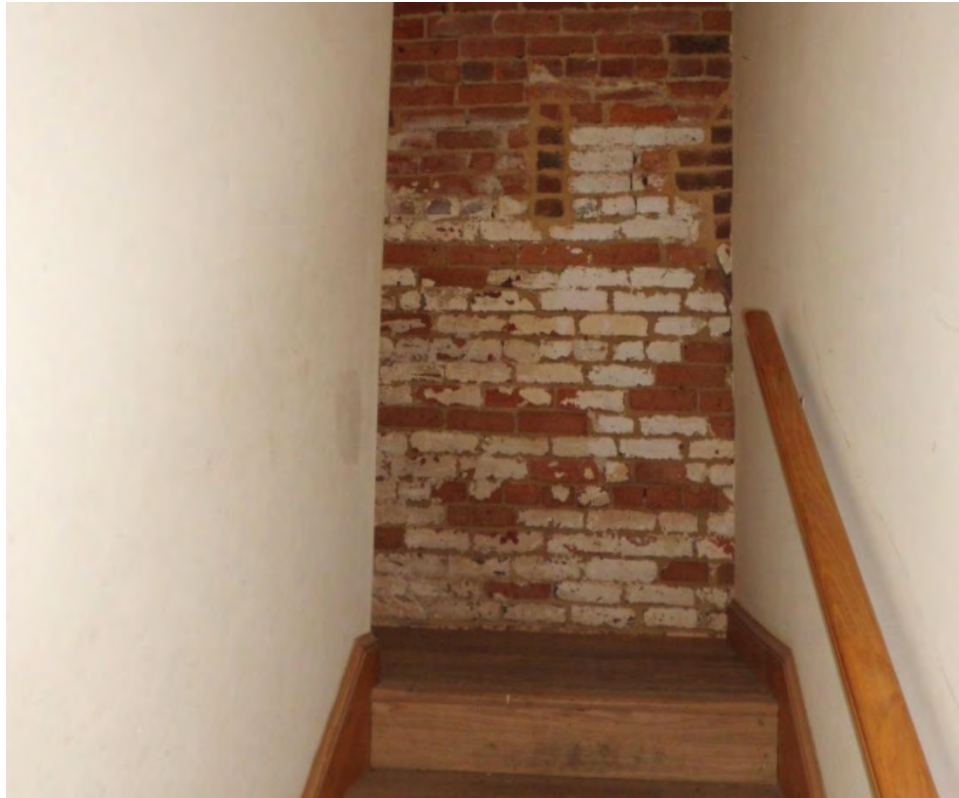
**Figure 31:** Brick spalling within northwest stairwell landing

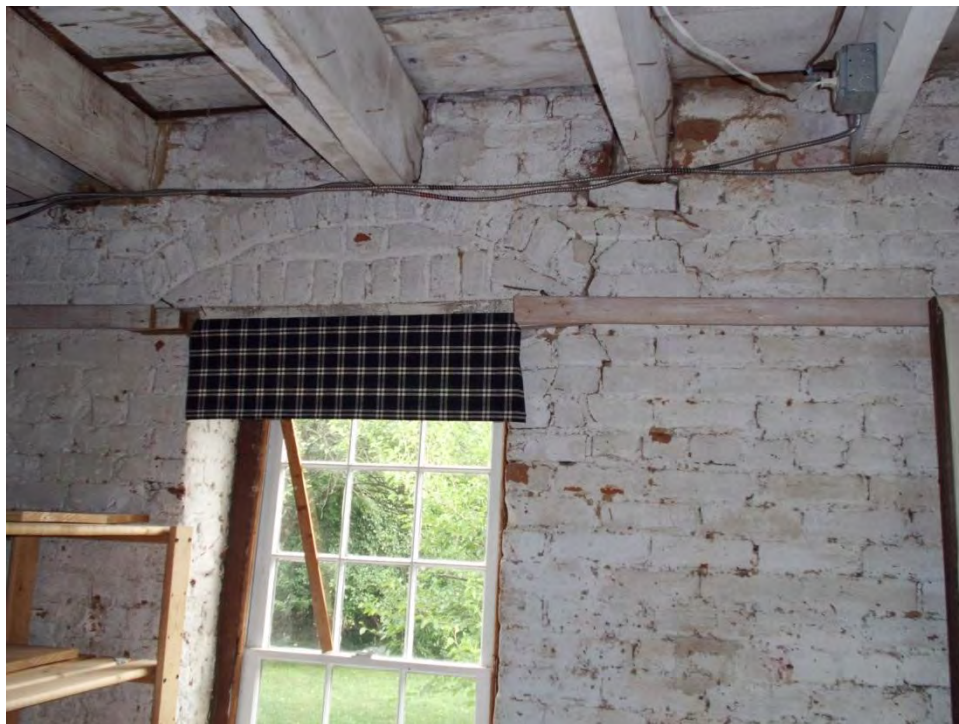
**Figure 32:** Second floor joist bearing deterioration at exterior masonry pocket

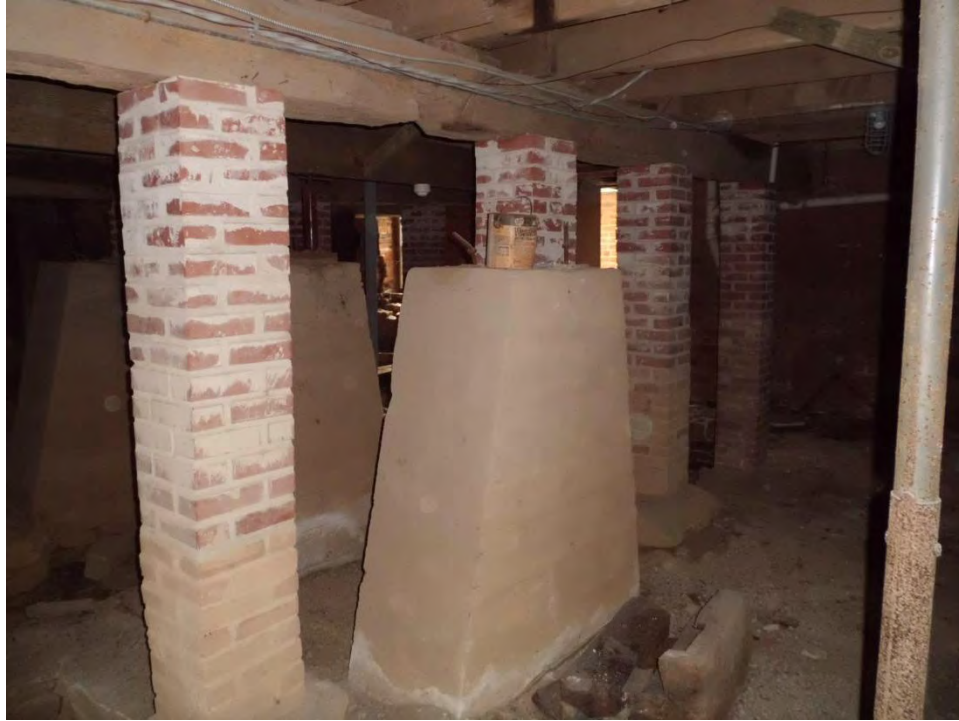
**Figure 33:** First floor beam re-supported on new masonry piers

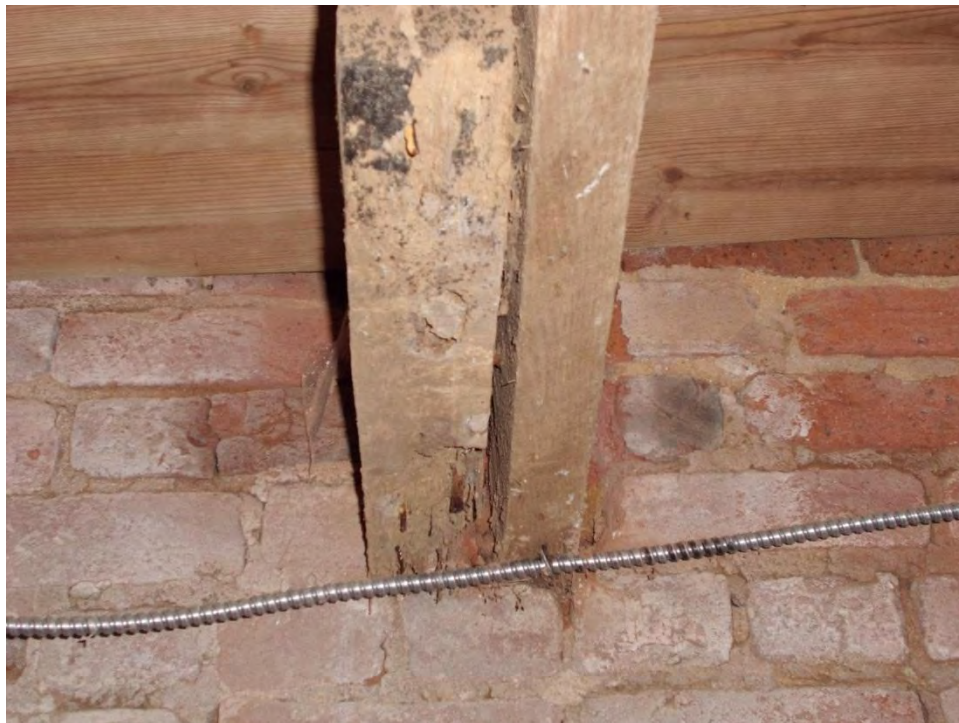
**Figure 36:** First floor joist bearing deterioration at northern masonry wall

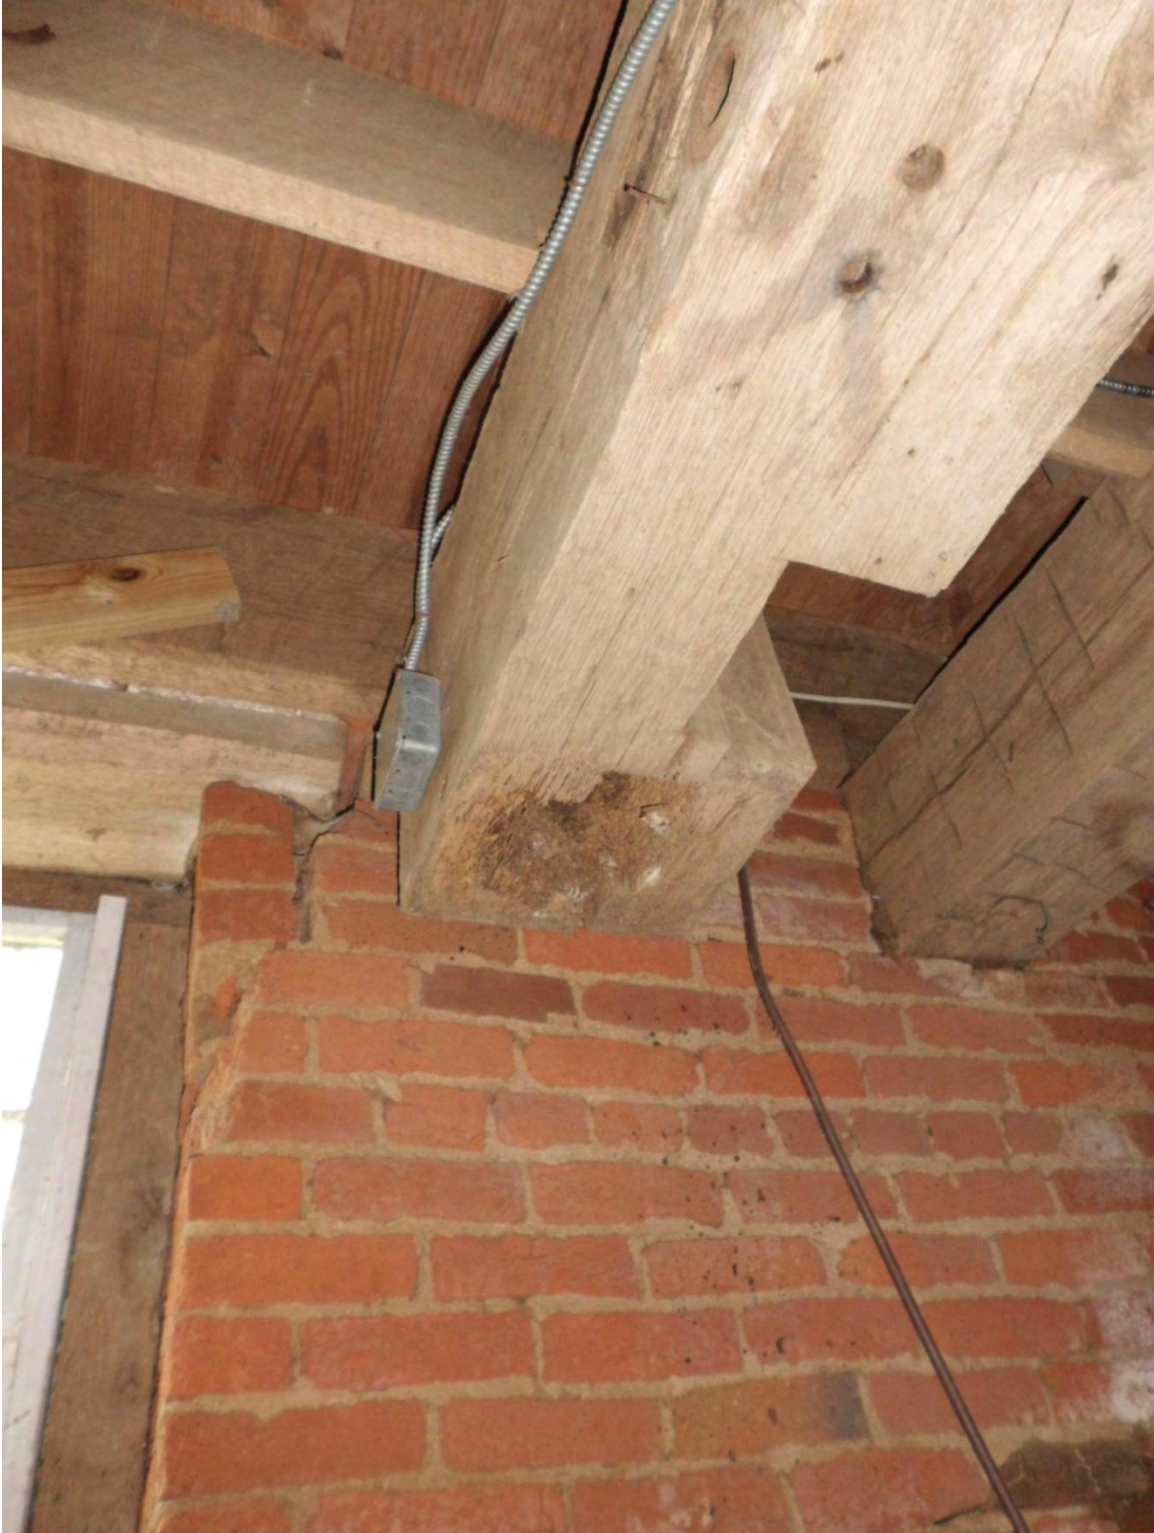
**Figure 43:** Hurst frame beam with loss of supporting post and cracked masonry at opening to left

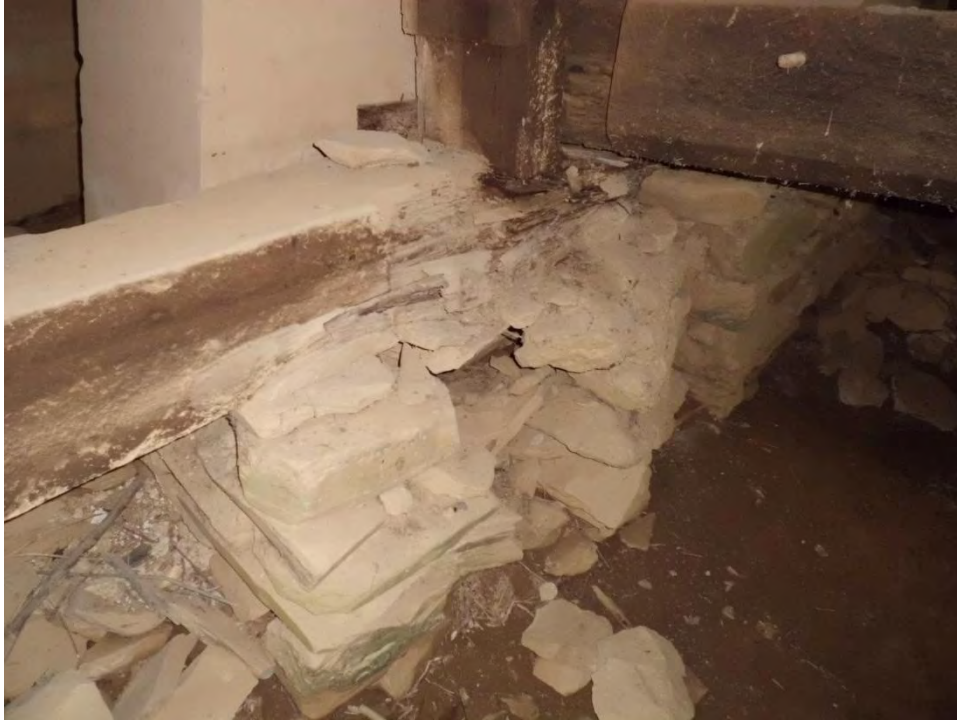
**Figure 44:** Hurst frame bearing deterioration and looseness in masonry below

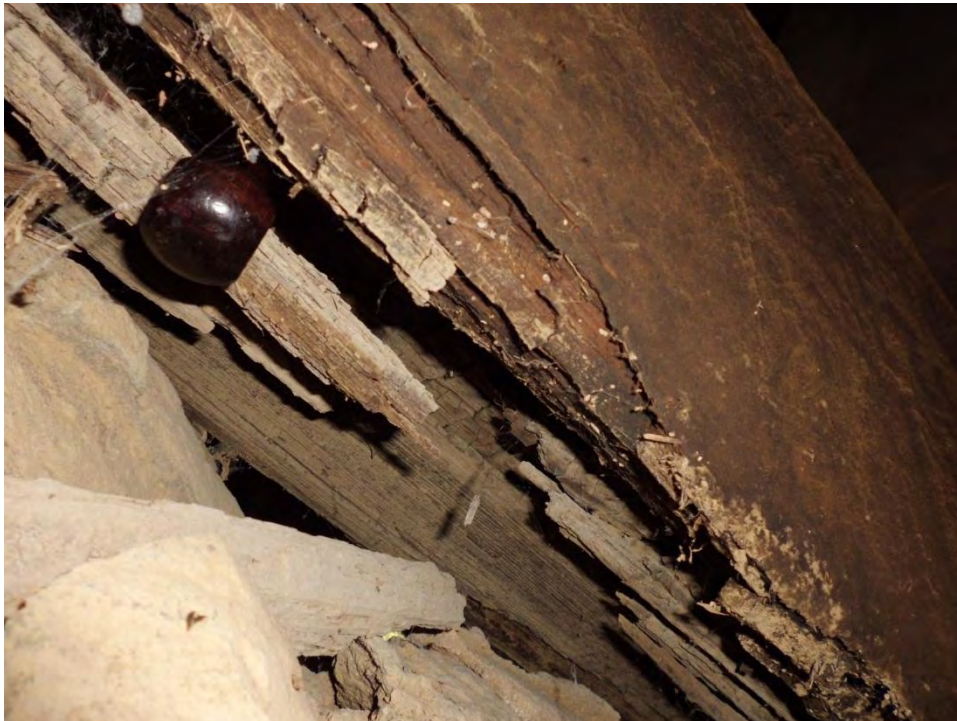
**Figure 45:** Hurst frame deterioration

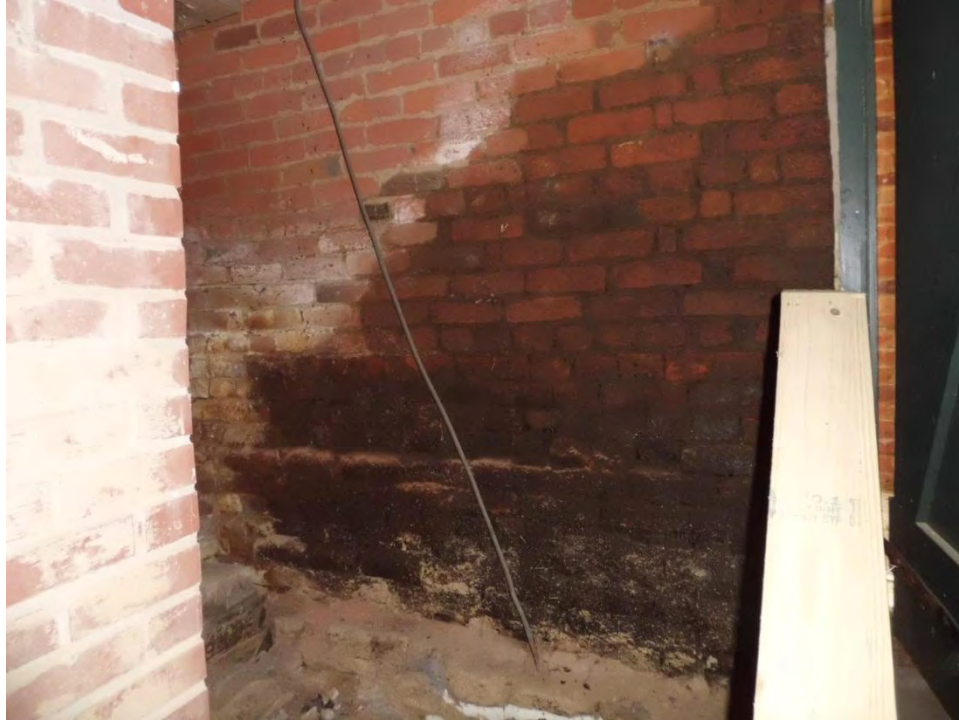
**Figure 48:** Saturation of brick masonry above west foundation wall

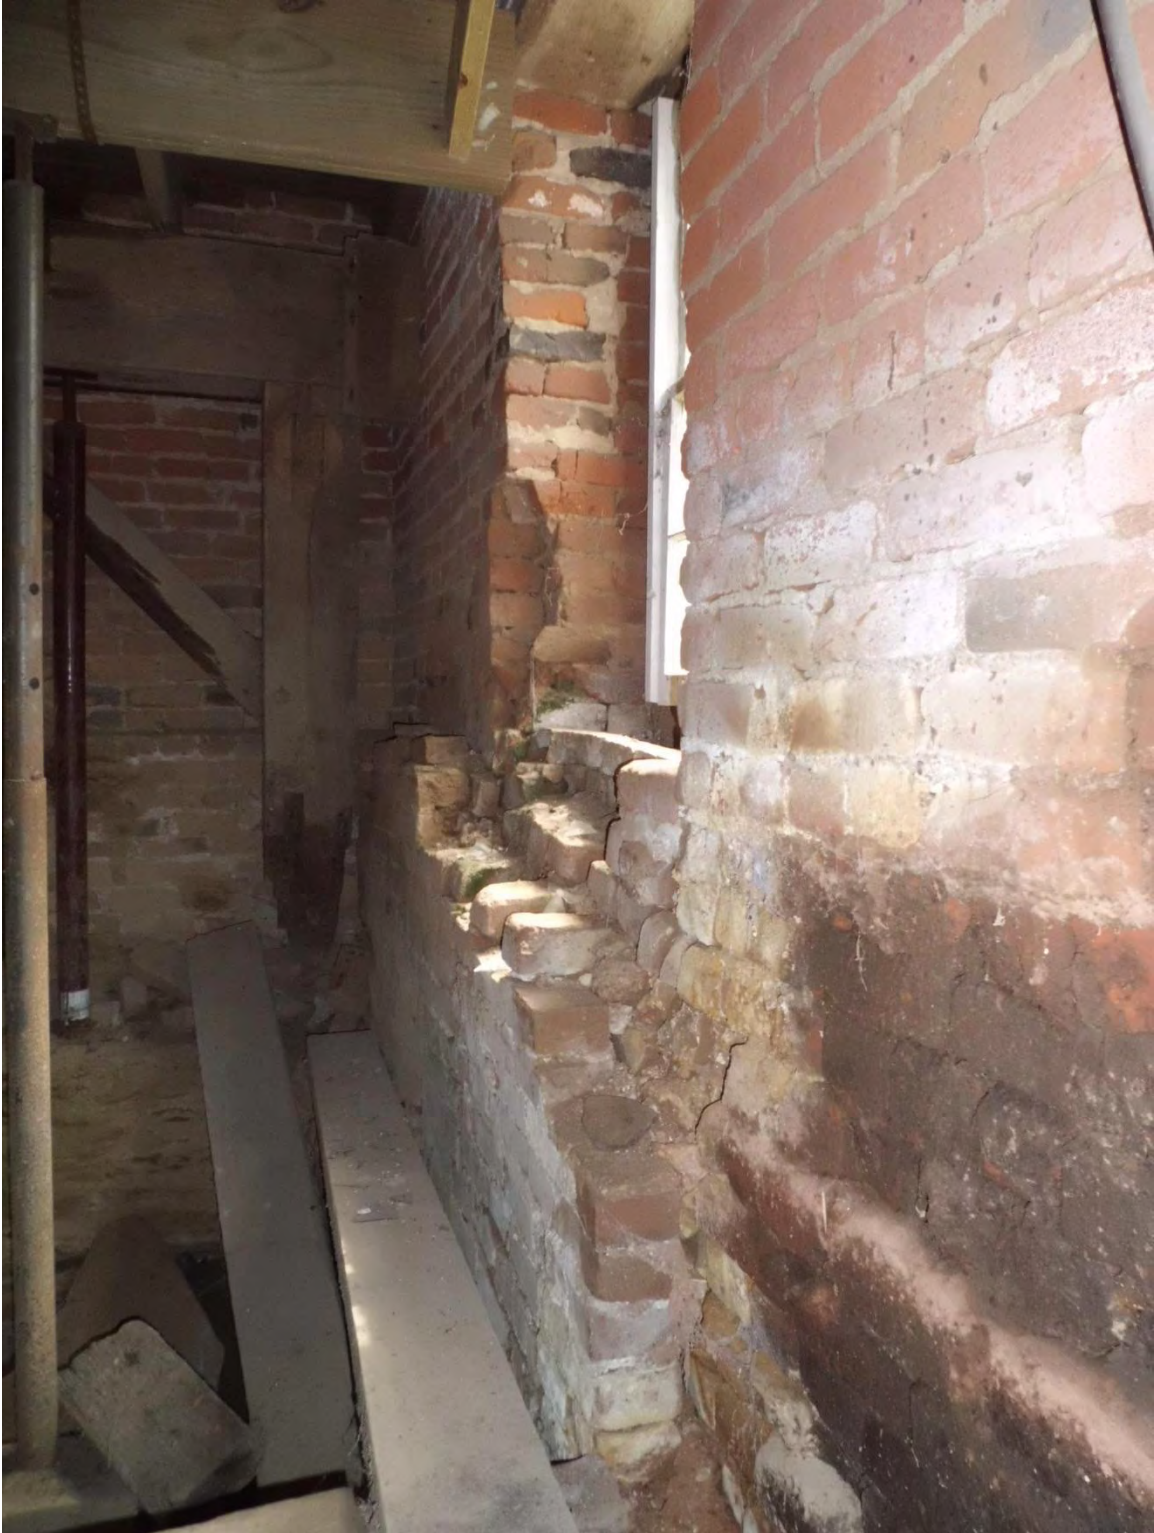
**Figure 49:** Deterioration of brick masonry at southern window of west foundation wall
