THE WATERFORD MILL  
*Waterford, Virginia*

HISTORIC STRUCTURE REPORT

24 May 2013

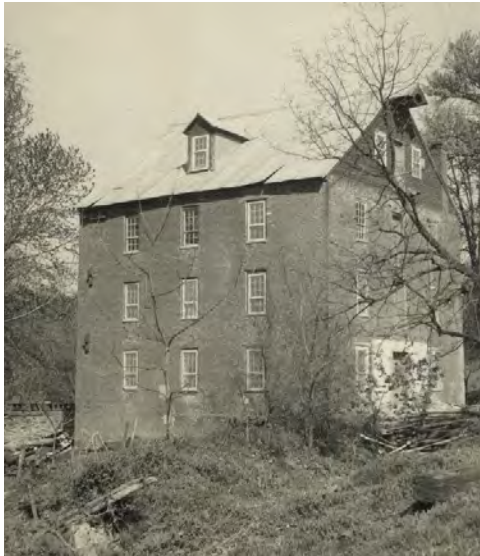
Waterford Mill soon after acquisition by Waterford Foundation in 1944 and after the west wing had been demolished. The corrugated metal roof appears loosely attached [WF].

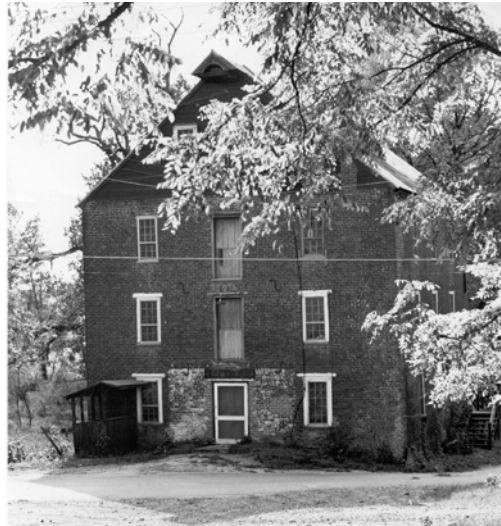
Waterford Mill, c. 1952. This shows the east wall after the canopy had been removed around the front door and the brick around door had been replaced. These bricks were replaced again and the sign above the door removed in 1983–4. The white-painted wooden screens were added to enhance ventilation of the building during regular use as a craft center [WF].

First on the agenda for the building were repairs to the exterior to make the building presentable and usable. The canopy over the east entry was removed, although the white paint surrounding the door remained. The brick around the first floor door must have been in very poor condition, because sections on either side were removed and new brick patched in.

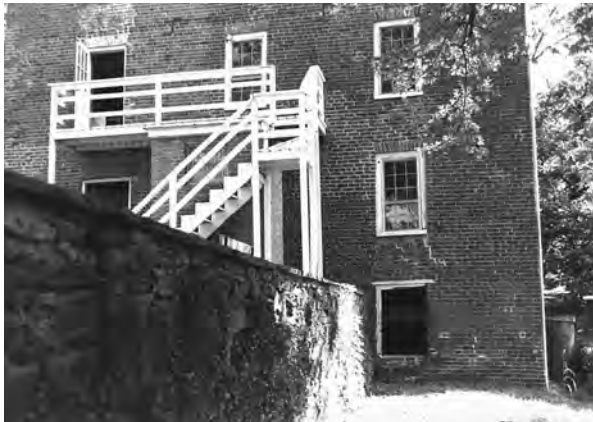
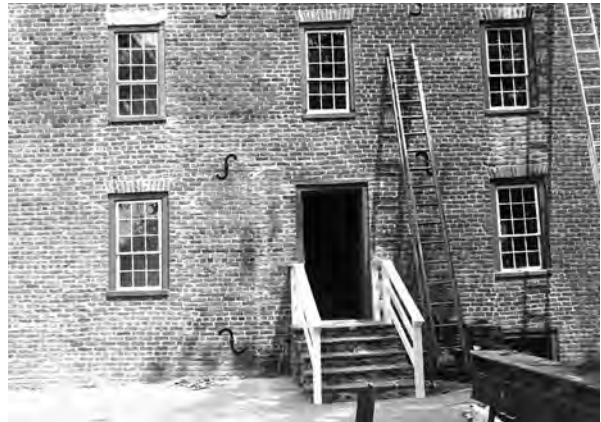
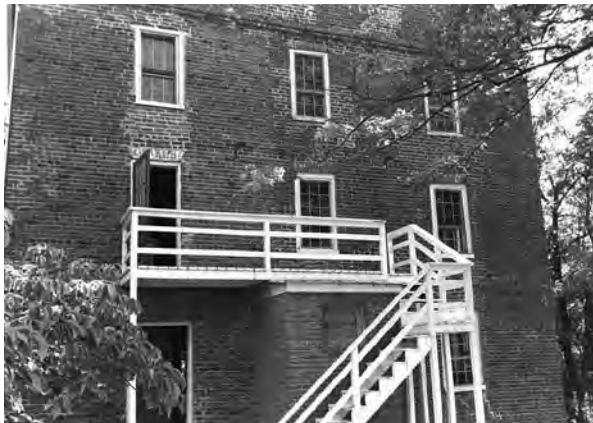
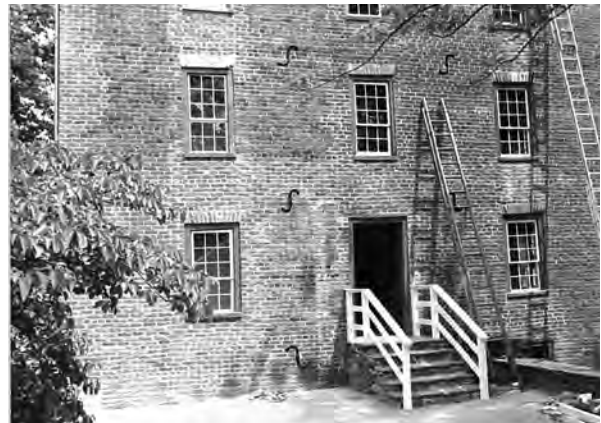
Documentary Photos from 1984 show the appearance of the west wall before and after the restoration [WF].

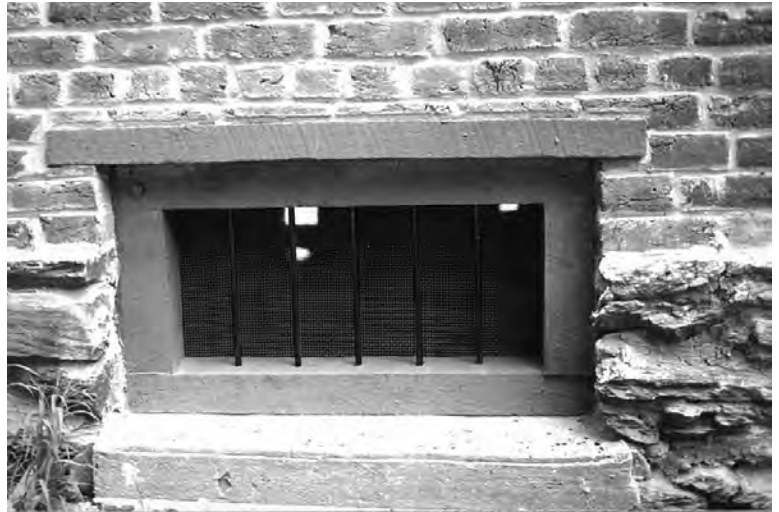
New basement vent in center of north wall.

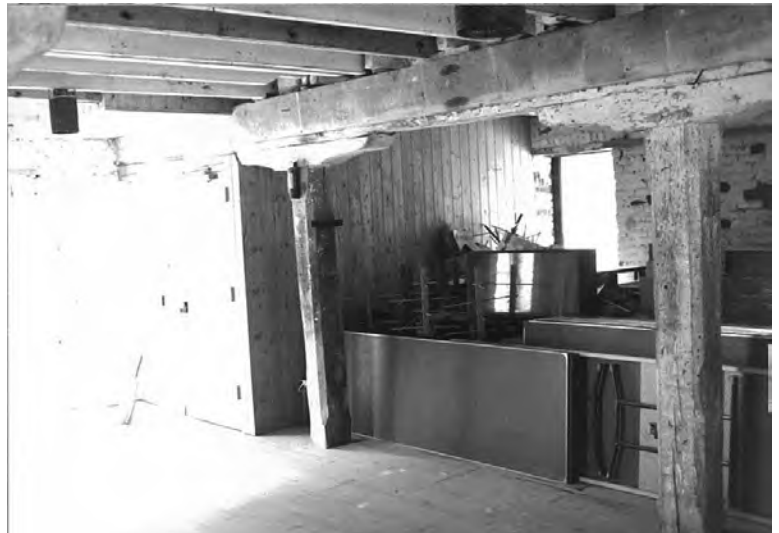
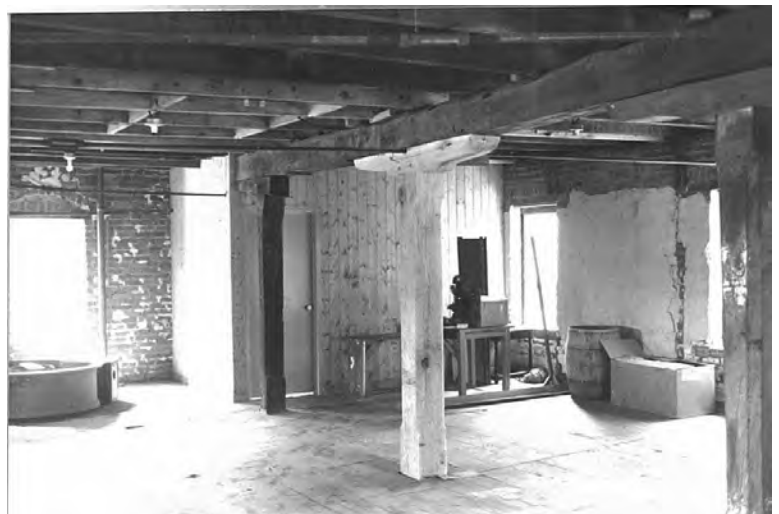
Exterior and Interior work performed in 1984 [WF].

Exterior work performed in 1983–4 included extensive and much-needed tuckpointing. Interior repairs included wholesale replacement of the wooden support posts in the basement with eighteen new brick piers and repair to damaged joists, bolster, blocking, and flooring throughout the building. The floors were leveled and blocking inserted in the joists throughout. Two brick piers were also added along the southern top beam of the hurst frame to support it and the floor joists it carries. Repair also extended to replacement of some posts on the upper floors, including several on the second floor and the addition of a center post on the north side of the third floor. Additionally, public safety issues were addressed by the provision of a second, enclosed set of stairs in the northwest corner connecting the first, second, and third floors. A small toilet room was provided that projected out from the west wall under the stairs. Longitudinal purlin plates supported by posts were added in the attic to support the roof structure.

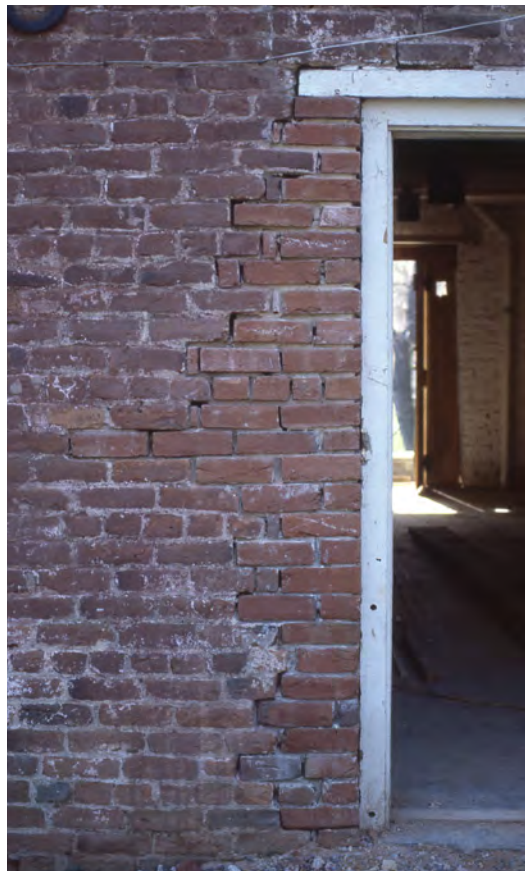
East entry door brick during repair, April 1984 [WF slide collection]

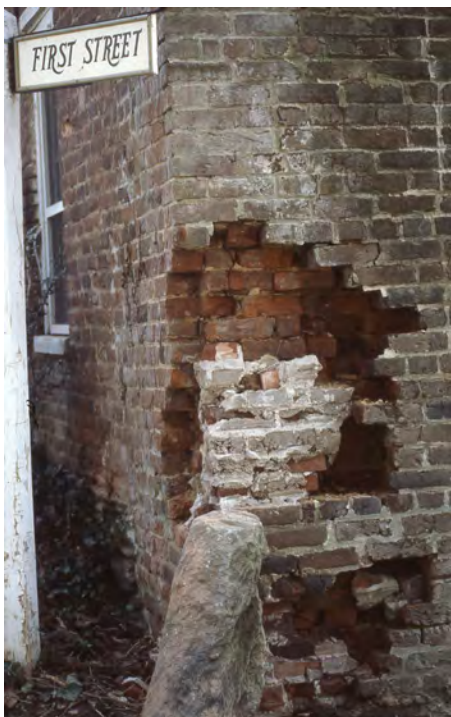
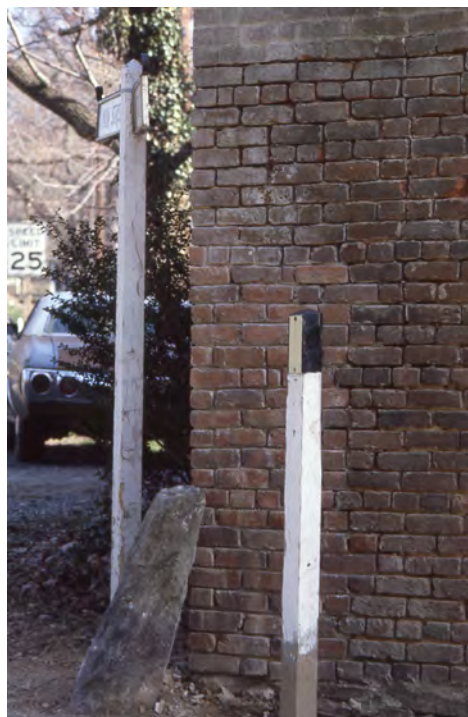
Northeast corner during and after repair, March 1984 [WF slide collection]

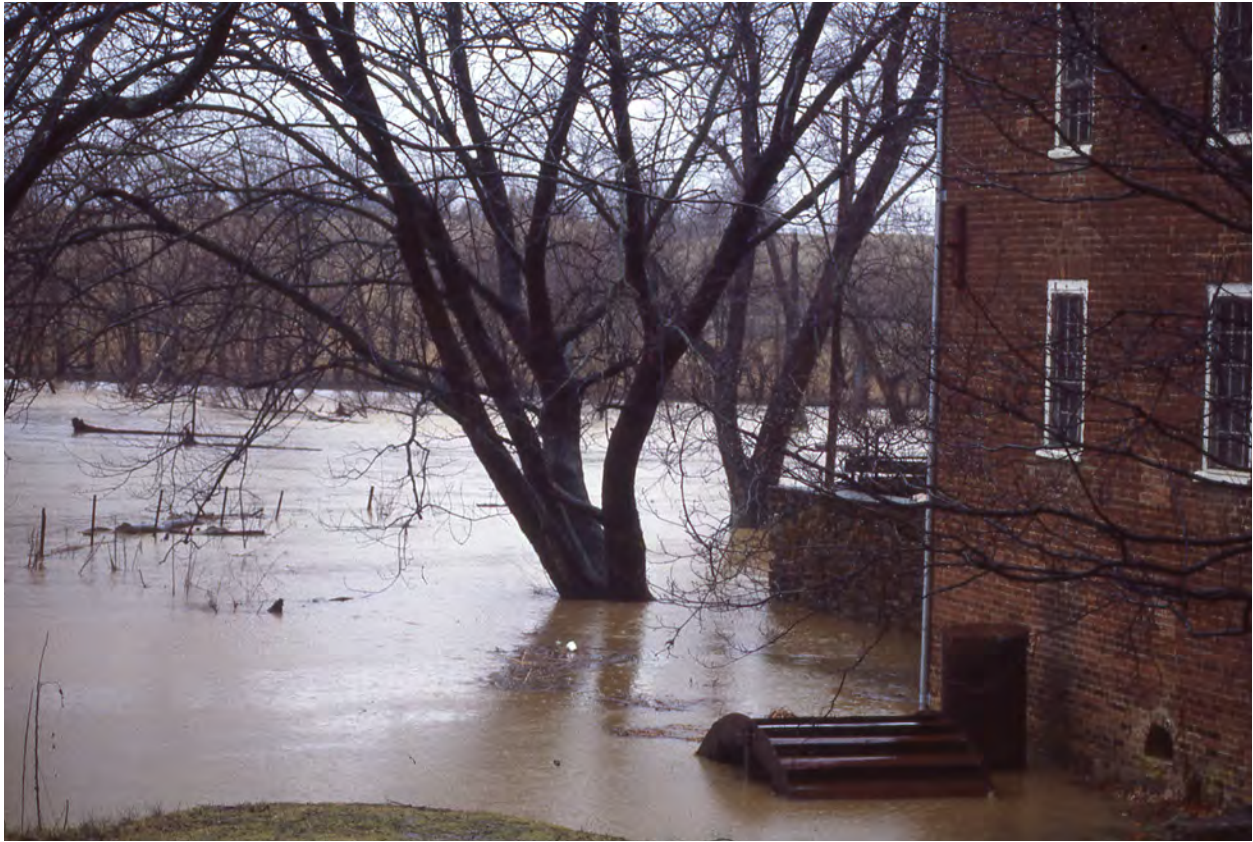
Left: Flood in March of 1984 [WF slide collection]

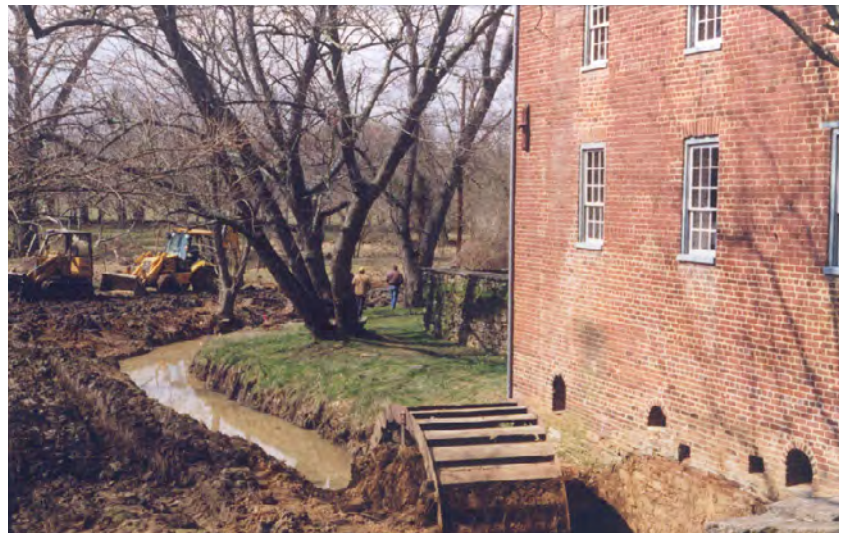
Waterford Mill, excavation of mill race, 1998 [WF].

Repairs were made in 1998 to the site and basement area based on the recommendations made in early 1997 [Structural Concepts, 6 January 1997, WF]. These repairs included cleaning out material from the basement and excavation of the tail race, which was intended to improve drainage of standing water in the basement. It also resulted in damage to a part of the stone wall defining the south side of the wheel pit, according to Neal FitzSimons, who visited on 25 March 1998 [FitzSimons, 25 March 1998]. The gear pit was not, however, excavated according to Derek Ogden's recommendations, although drains were observed about five to six feet below the water wheel shaft [Gravatt, Waterford Mill Summary, 1998, WF].

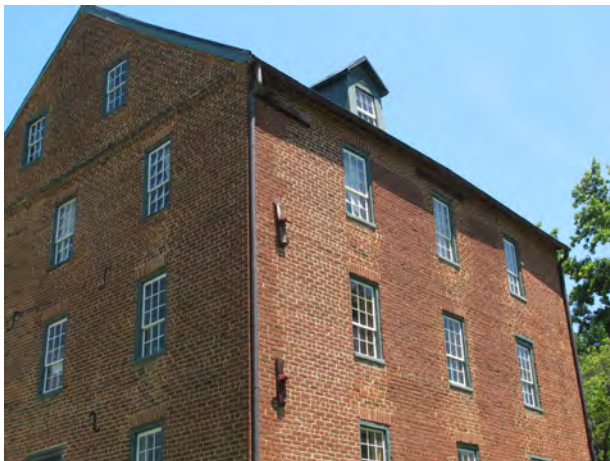
South side, Waterford Mill, 2012

The south side of the mill, like the other walls, has three evenly spaced window bays. The eastern end of the building was rebuilt in the mid-to-late nineteenth century. The bond courses of headers in the rebuilt section do not, for the most part, line up with the bond courses to the west, but do line up with the bond courses in the east end. The windows in the eastern bay have been rebuilt as well, with wood lintels that protrude to either side of the window. The window frames themselves match the other windows in the building and were probably reused when the wall was rebuilt. Late-nineteenth-century iron tie rods project at the second, third, and attic floor levels near the west end and the forces are distributed by beveled wooden plates. The replaced section of wall appears to correspond to the marked change in level of the stone foundation below. A diagonal crack extending from the foundation to the western

corner of the east first-floor window sill corresponds to the replaced section of brickwork. This could represent an area of differential movement that required the rebuilding of the entire east end to prevent collapse of the mill.

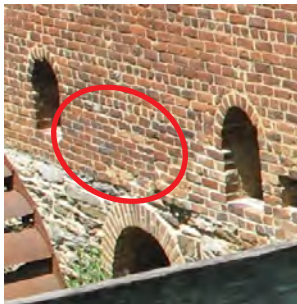
Left: View of western archway from northeast, 2012. The wall is patched just above and to the west of the large arch where the wheel shaft would have entered the building (circled).

A patched area of brick above the arch is more carefully laid than the surrounding brick work. It appears to correspond closely to the entry point for the wooden water wheel shaft required by our analysis of the hurst frame. In order to work, the shaft had to enter the mill above the rear sill of the hurst frame (beginning about 10" above the stone foundation level). The three small arches appear to have been added at the same time that the wooden gearing was removed, possibly to improve ventilation, although the odd juxtaposition of the large and small eastern arches suggests that one was added before the other. In any case, the use of brick arches in a stone wall suggests that the large arches were not original, but that they were added in the mid-nineteenth century or later.

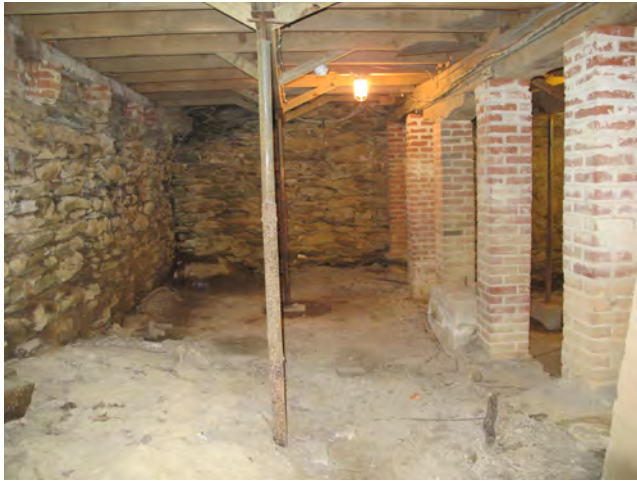
The north bay of the basement looking east

The mill is divided into three structural bays from north to south by two large beams on each floor. The building is divided into four structural bays from east to west by three evenly spaced, approximately 9 1/2" square wood posts with lamb's tongue chamfered corners. The posts and the rest of the framing are built of red oak. These support two beams on each floor measuring approximately 9 1/2" wide by 11 1/2" tall. Forces are transmitted from beam to post by means of a traditional bolster with sawn ogee ends. The posts are mortised into the bolsters and fixed with two pegs. The bolsters are attached to the beams by pegs at each end. Each floor is carried on 3"x 10" pit-sawn joists that span from north to south between the beams and pockets in the long walls of the building. The arrangement of six posts and bolsters was also used in the basement, but the posts rotted away and only one bolster survives. This may have been a principal cause of the downward bowing at the center of each floor. Many of the joists

were sistered in the 1983–84 repairs. Much of the damage repaired at that time was a direct result of the buildup of moisture in the basement that resulted from the backfilling of the tail race in the 1940s.

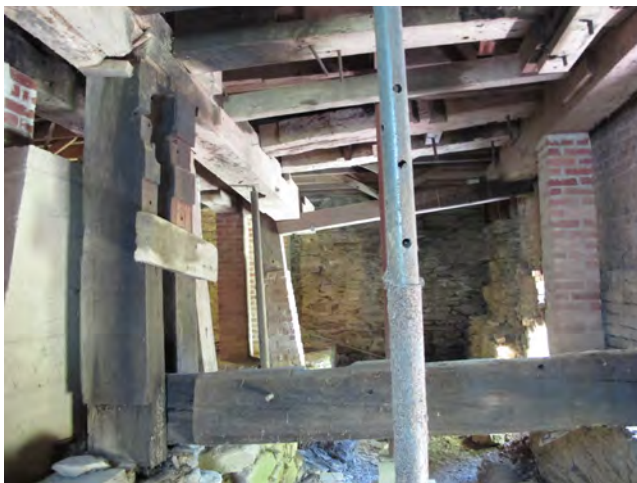
The hurst frame looking east with the surviving bridge beam in foreground.

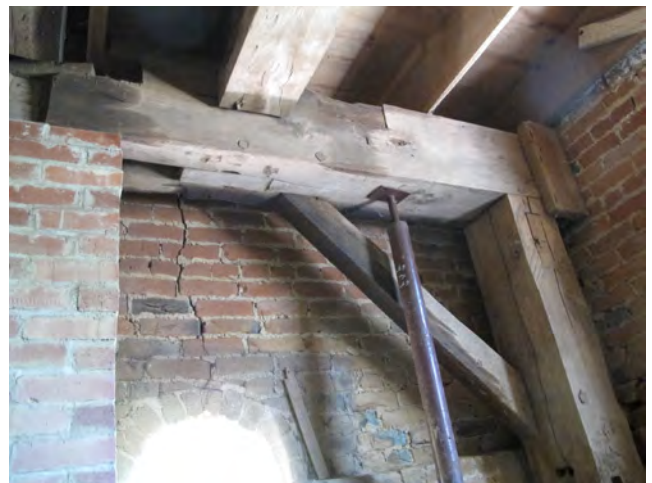
Hewn corner posts extended between the top and bottom members. These were 5'-6" in length and measured 10" in width and 12" in depth. Only the upper portion of the corner post at the southwest corner survives, although the northwest corner post was shown in the measured drawing made in 1983. The corner post contains the sole evidence of the original bracing. The north and south sides of the hurst frame were connected by girts near the top of the east and west end. These were mortised into the corner posts just below the side beams to avoid a conflict of tenons. A mortise-and-tenoned brace measuring 6" tall by 4" deep still extends up from the post into the bottom of the top beam. The tenon survives for a similar brace extending down from the post to a missing girt at the bottom.

Southwest corner post seen from northeast showing surviving brace

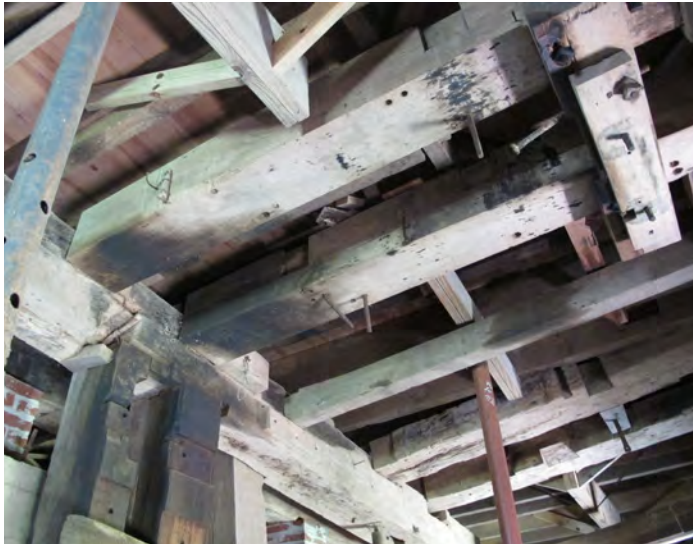
Above: Mill beam and western and central stone bearers looking northeast.

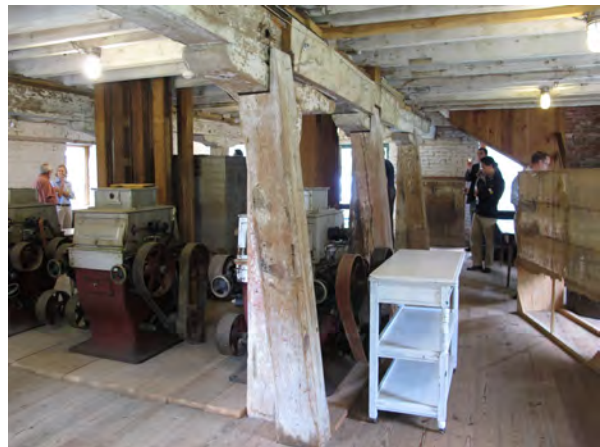
First floor looking east from south structural bay showing added braces and roller stands.

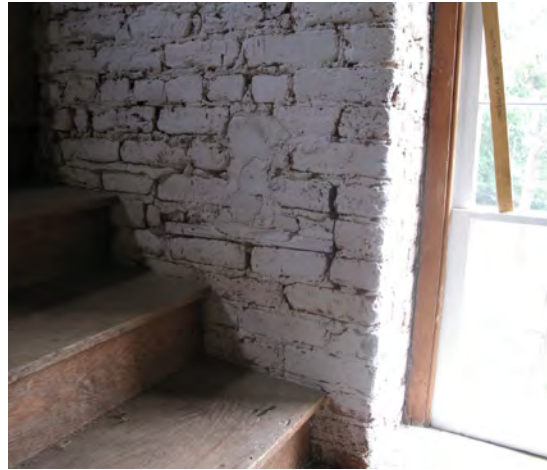
Infilled mortise for landing support at center, first-floor stair.

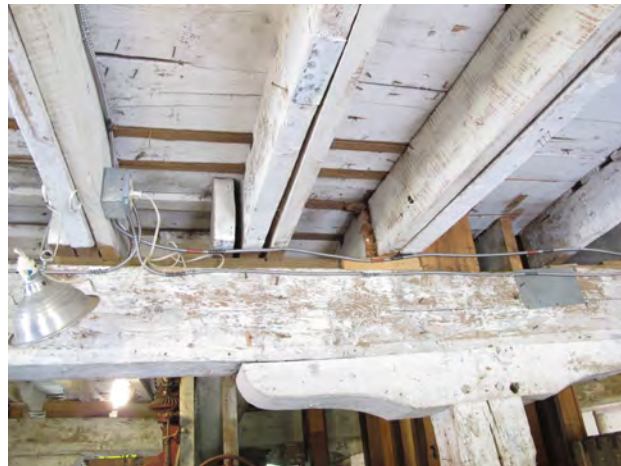
The southeast post on the first floor, showing typical blocking and sistering performed in 1983-4.

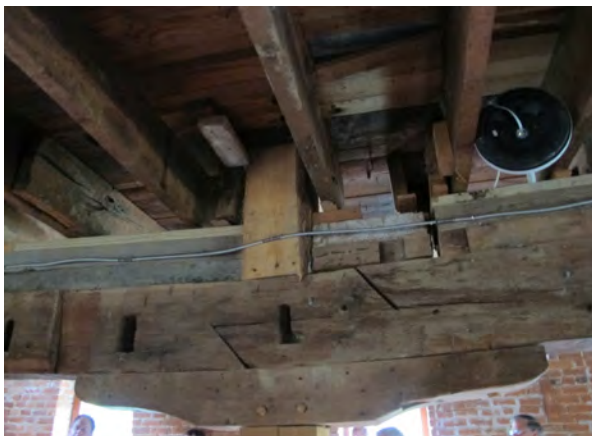
Typical scarf joint, center of northern beam on second floor.

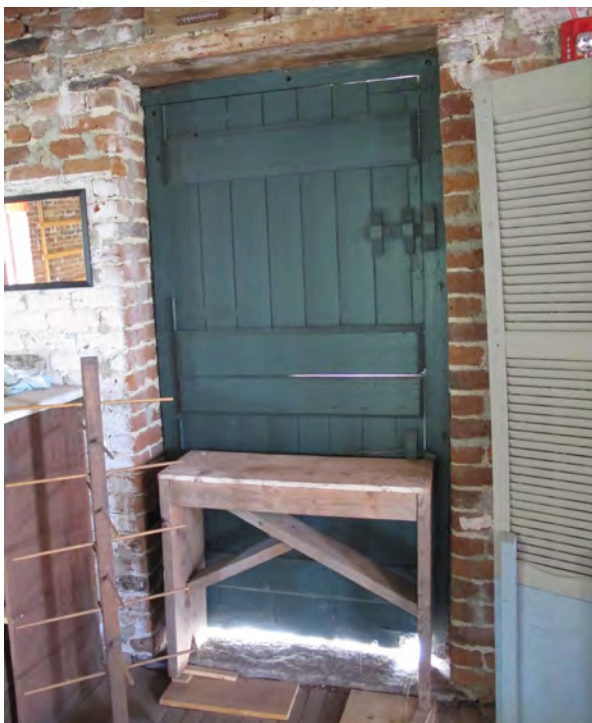
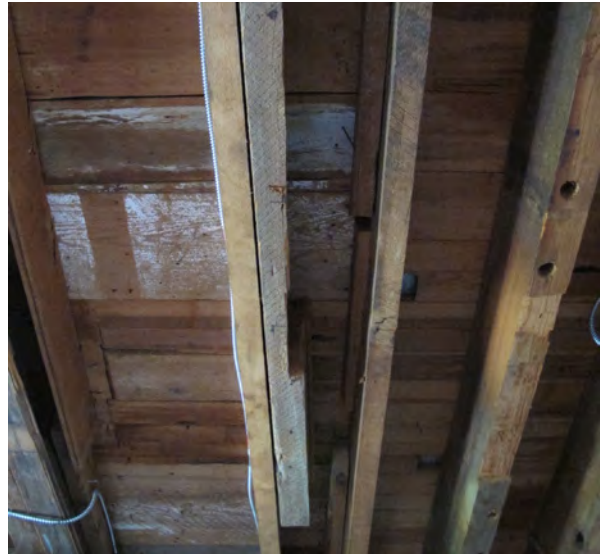
Above: The two sets of peg holes on the right (located near the west end of the center structural bay) are probably the location of a support for a central longitudinal second-floor power shaft. Looking north at Joist 18, Zone B, Sheet A-15 on the 1983 record drawings. The floor to the left is mostly old and to the right is replaced.

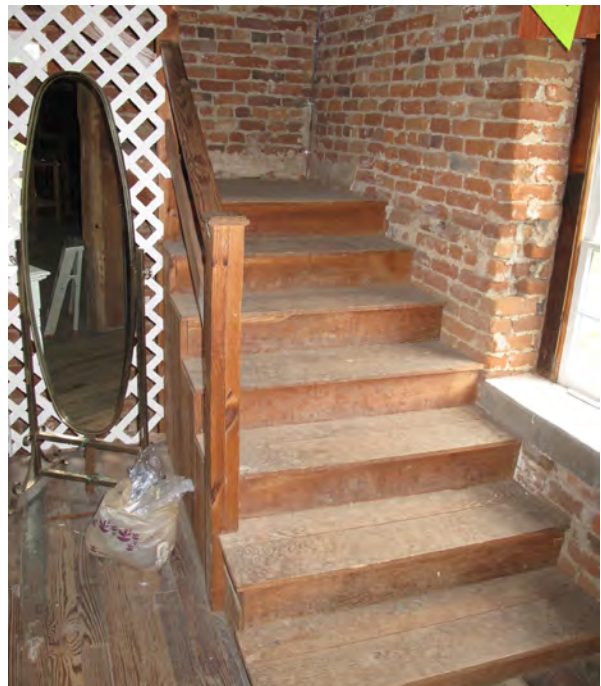
Above: The second-floor stairway showing modern risers and treads. The earlier landing may have been supported on a joist that was held in the notch in the window jamb just above the sill before the stair turned and descended to the north.

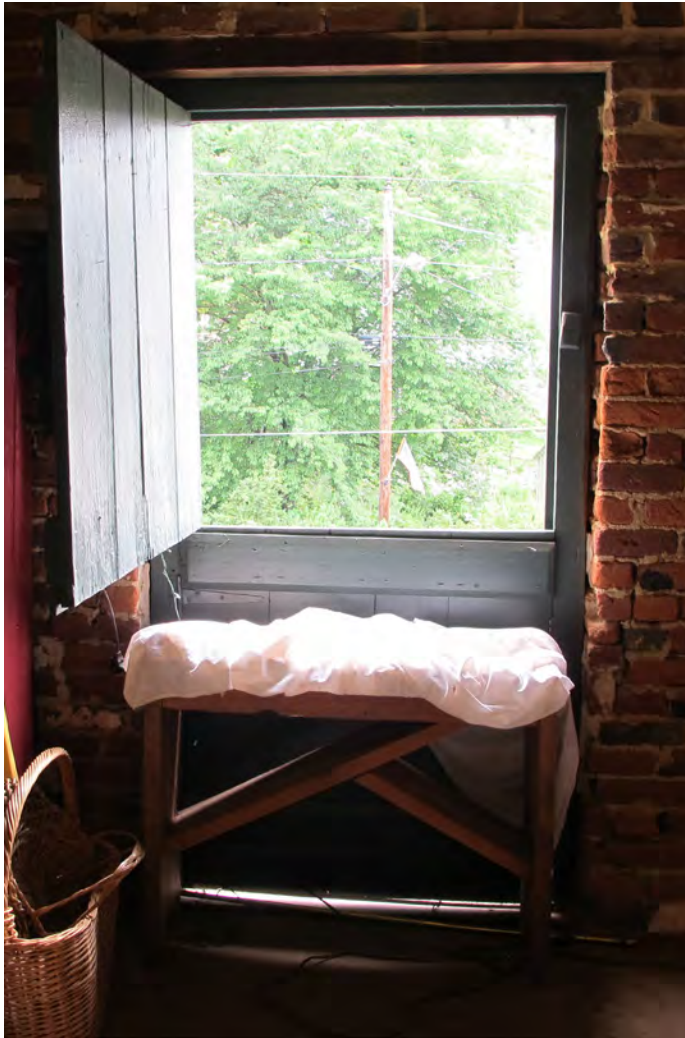
The disturbed brickwork below the sill level of the former window shows its conversion to a door in the late nineteenth century.

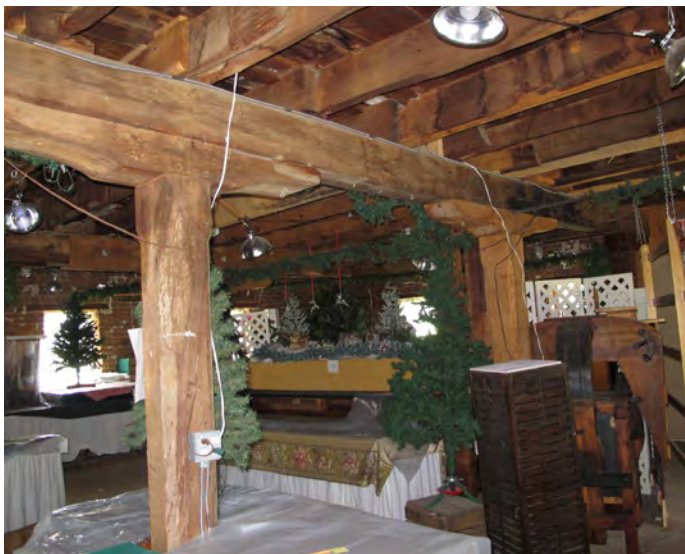
Third floor looking southwest from the north bay, showing the 1983–84 post at the center right. Note that there is no scarf joint over this post, making this the only continuous beam in the building.

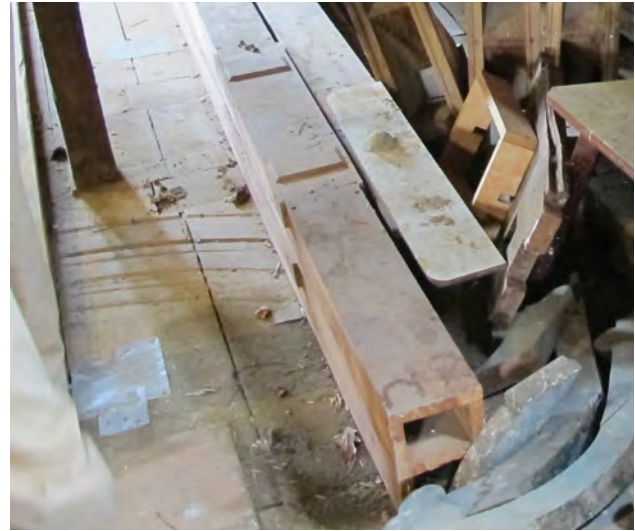
Right: Traces of a hopper boy flight arm on the attic floor

The floor boards in the center of the north side bear the deep circular grooves that indicate the early presence of a hopper boy, one of the inventions of Oliver Evans that helped revolutionize milling in the late eighteenth century. The hopper boy at Waterford Mill, which cooled and dried flour by raking in a circle, was about 7 feet in diameter.

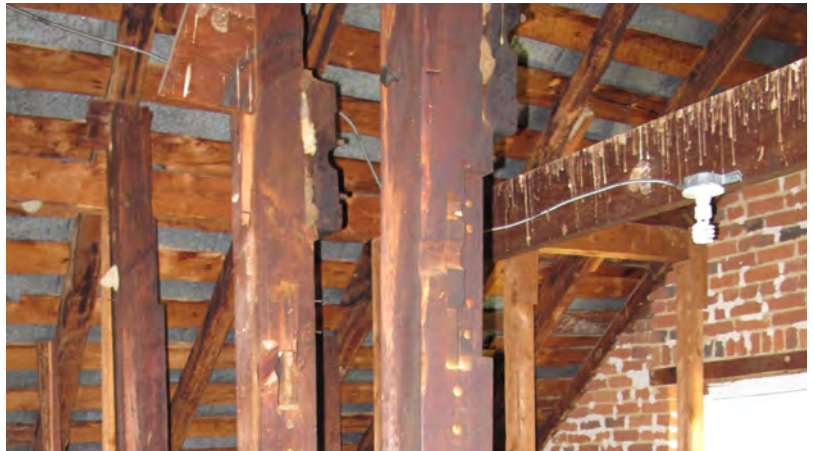
Grooves and notches in the vertical posts at the west end of the auxiliary drive shaft (located above) show where bevel gears connected to another drive shaft.

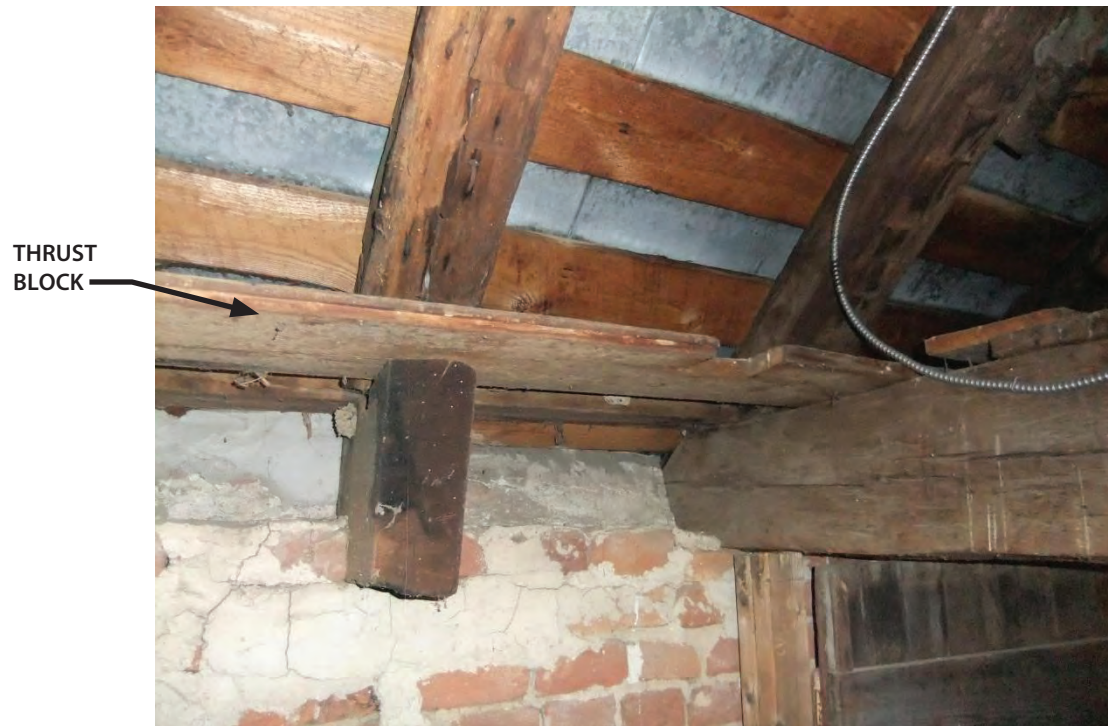
**Figure 5:** Roof rafter bearing at top of masonry wall. Note use of thrust block.

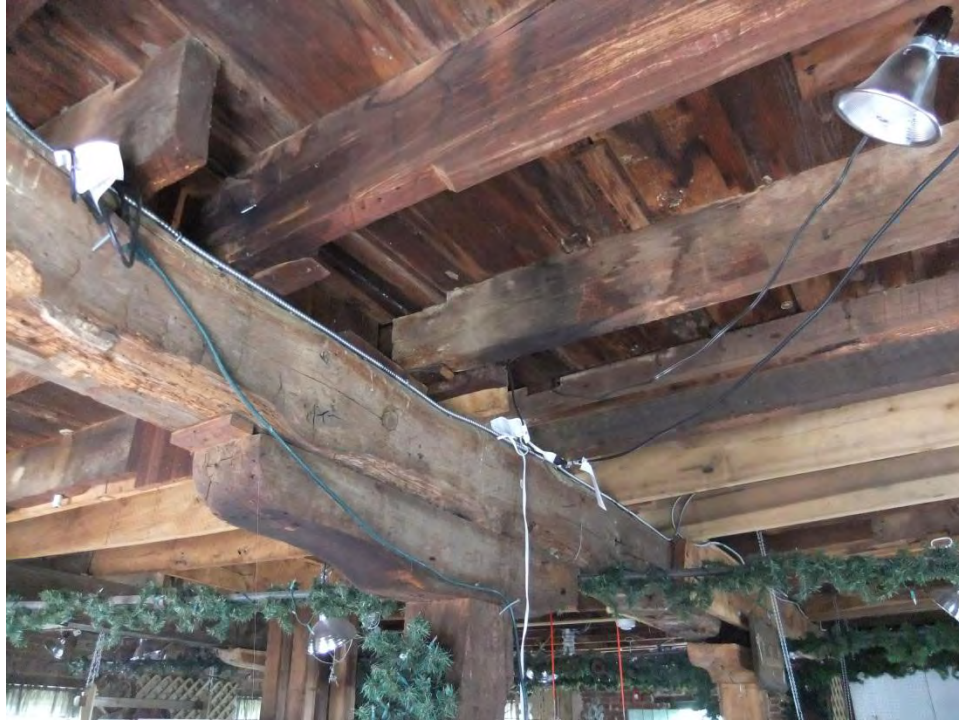
**Figure 9:** Attic joists on longitudinal beam below. Note leveling shim pack and column capital.

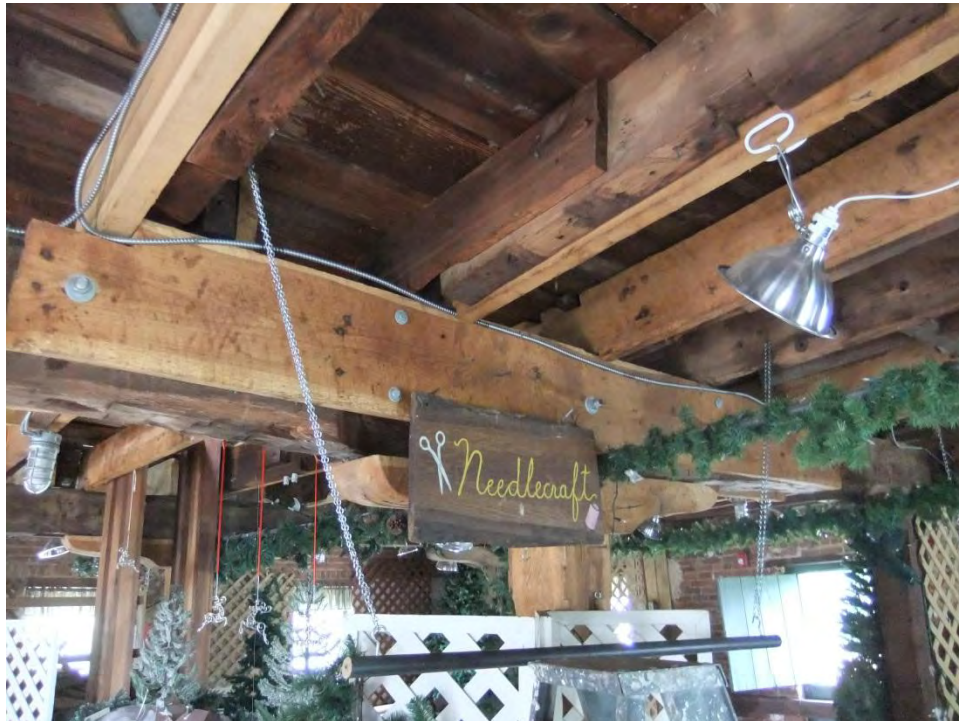
**Figure 10:** Attic level longitudinal beam sister reinforcement

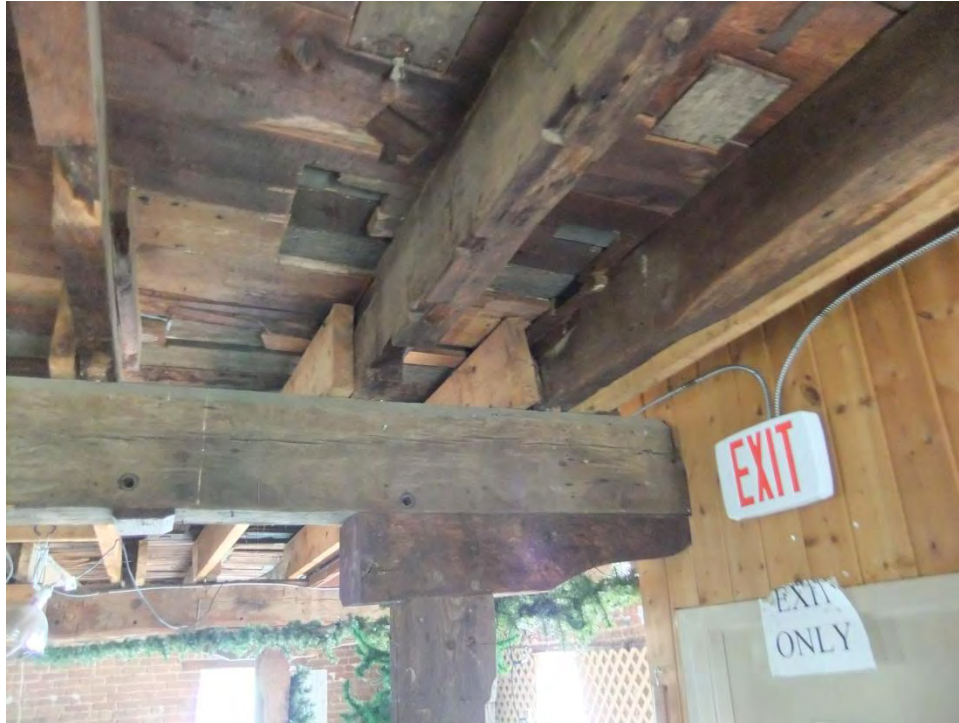
**Figure 15:** Attic floor framing modifications

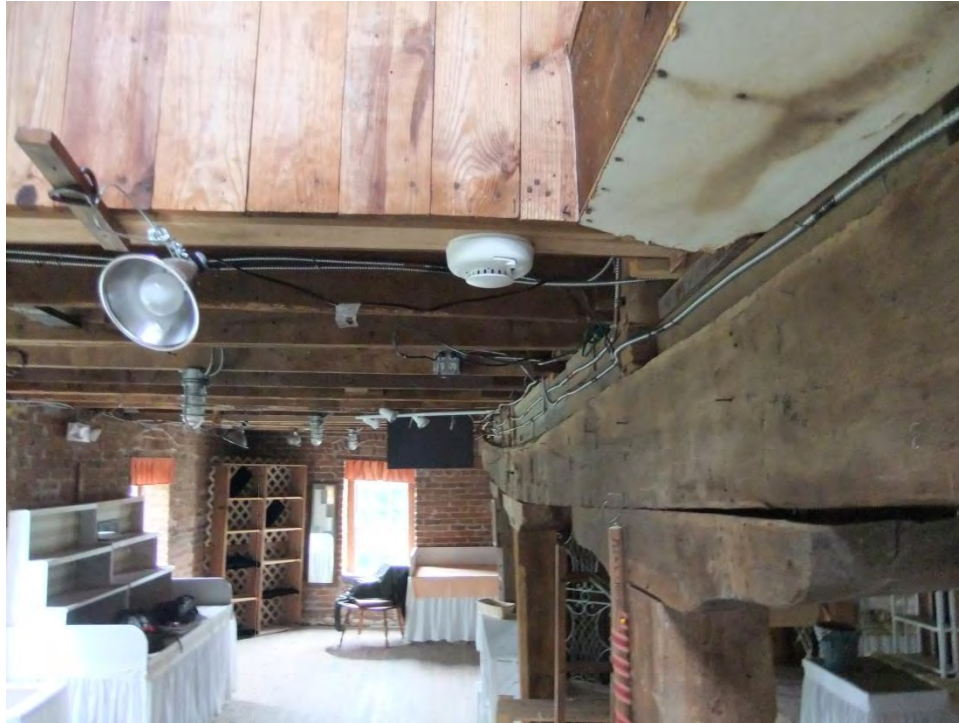
**Figure 17:** Third floor beam deflection

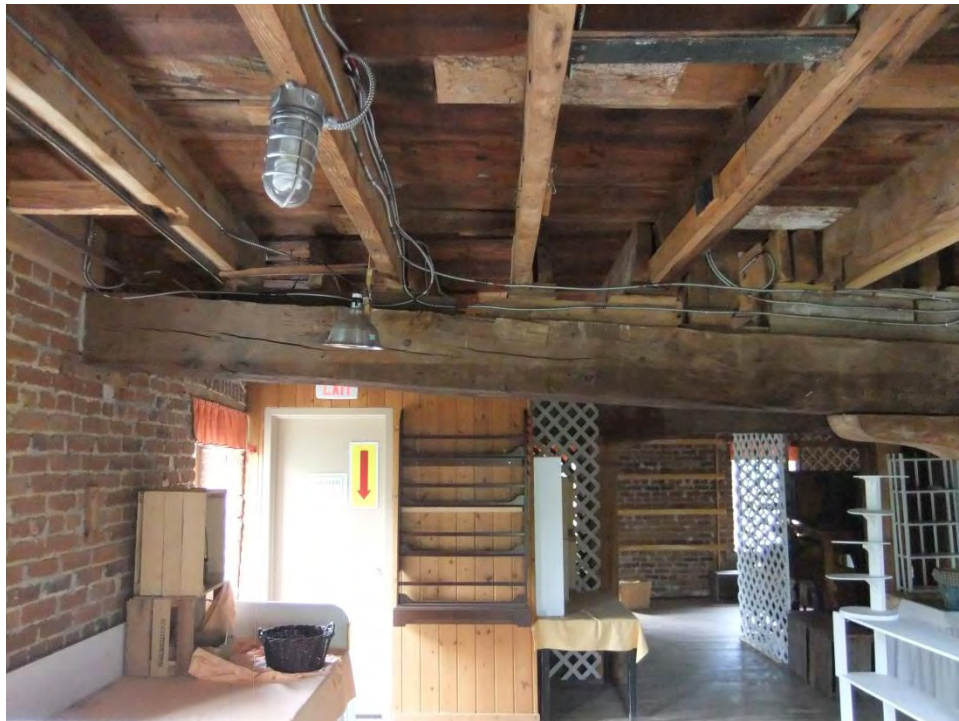
**Figure 18:** Third floor beam deflection

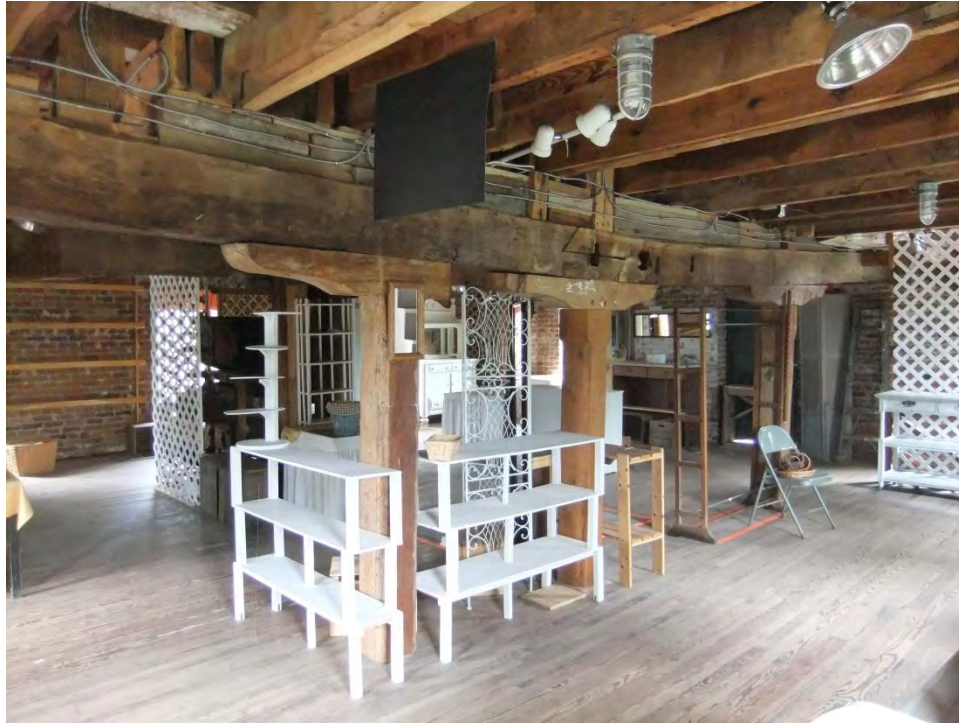
**Figure 19:** Third floor relocated column and beam deflection

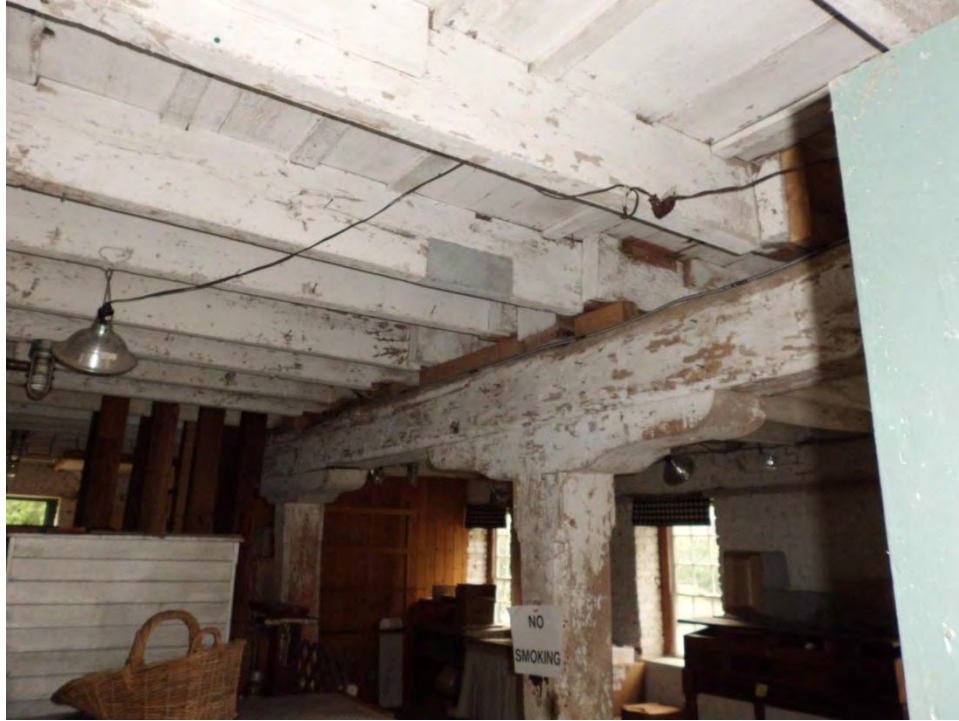
**Figure 23:** Second floor joist and leveling shims

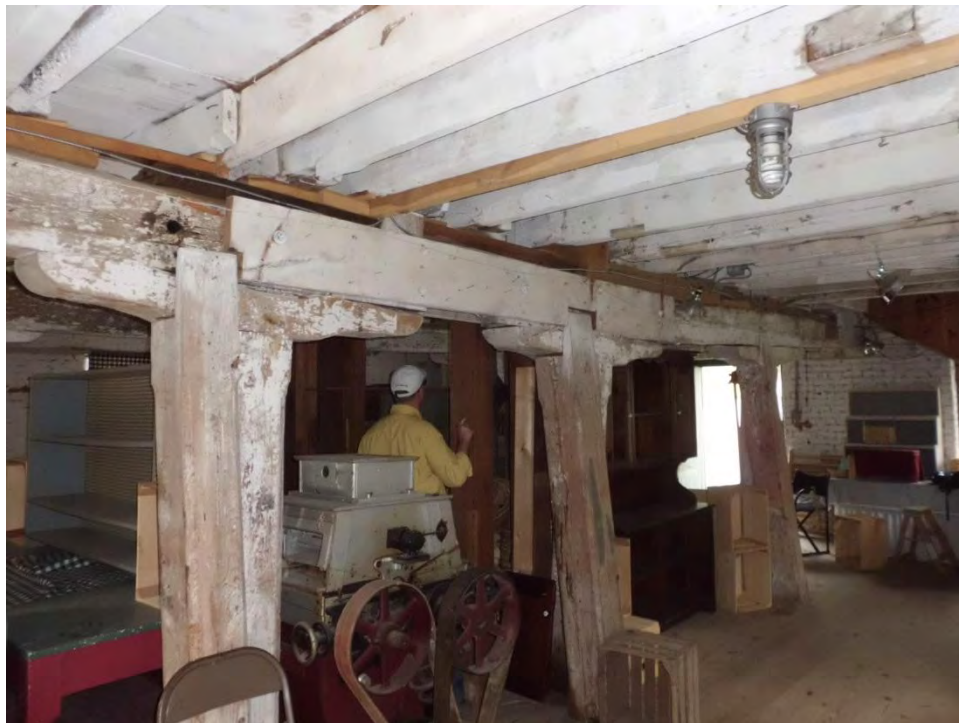
**Figure 24:** Second floor longitudinal beam sister reinforcement.  
Note misalignment of post above and post below at left.

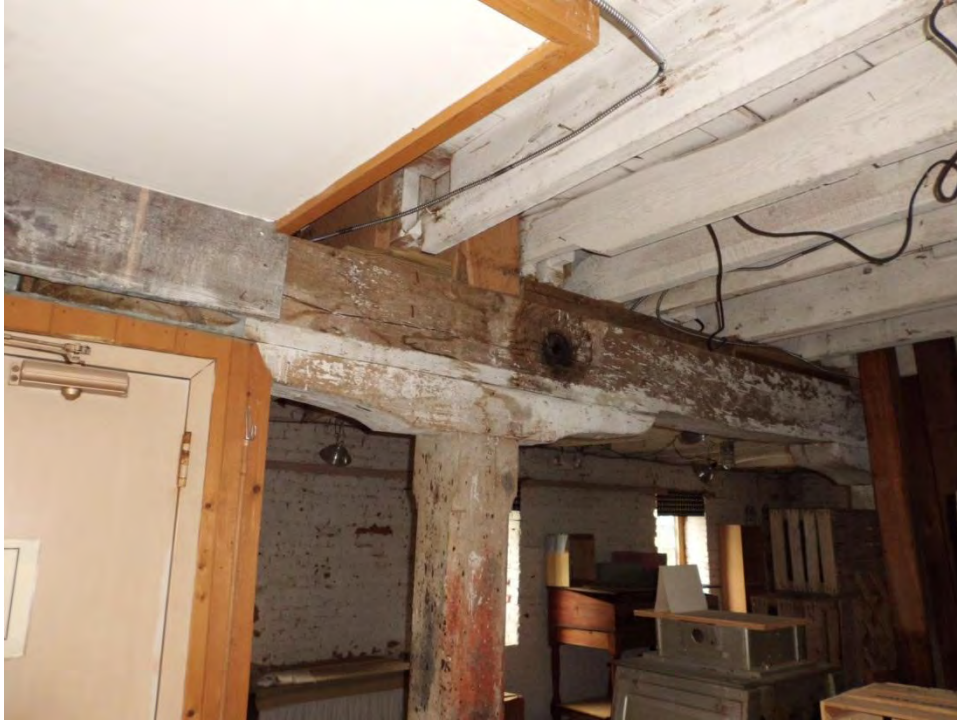
**Figure 25:** Second floor longitudinal beam notch

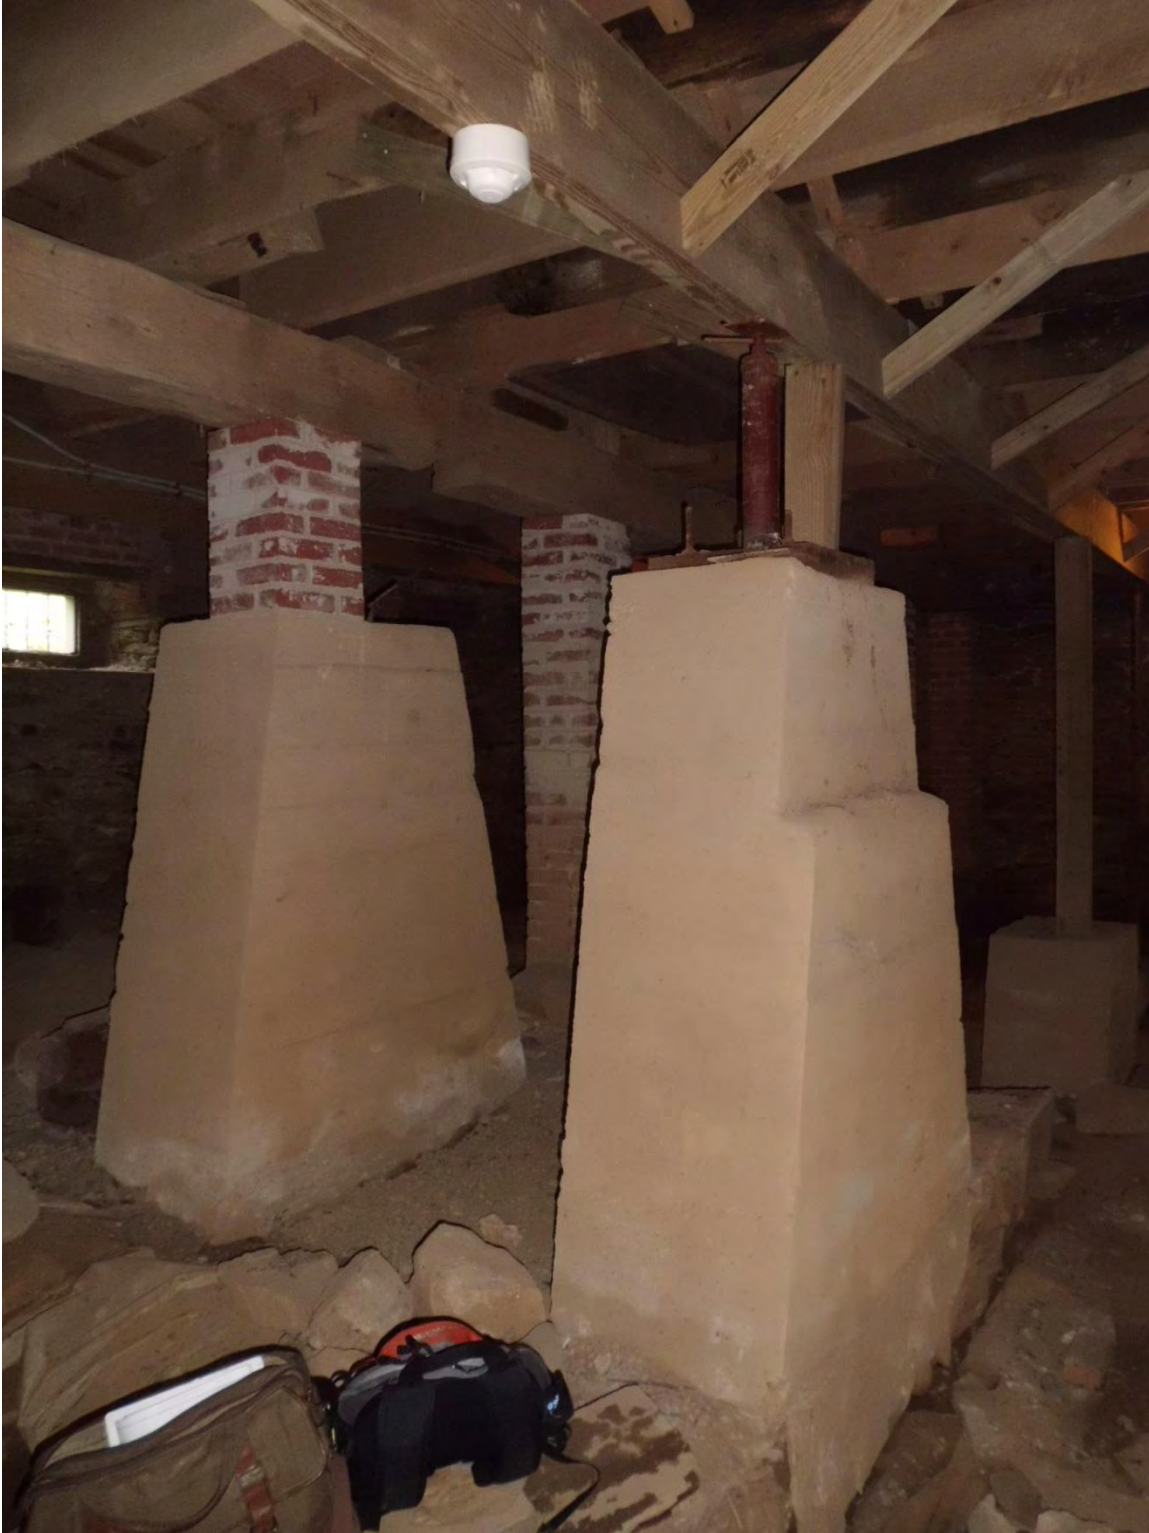
**Figure 34:** First floor shoring and new masonry pier support
