THE WATERFORD MILL  
*Waterford, Virginia*

HISTORIC STRUCTURE REPORT

24 May 2013

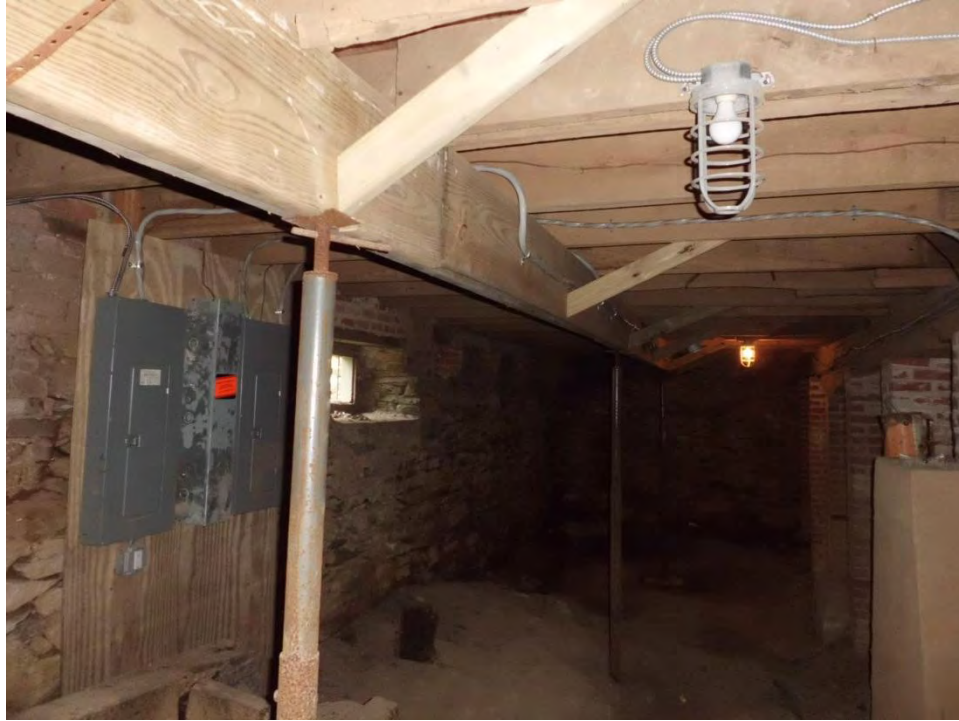
has been provided in the east-west direction (Figure 35). New doubled solid sawn lumber beams bearing on post shores have been placed to reduce the span of the joist framing. This also reduces the loads applied to the longitudinal beams and associated pier supports. The post shores were observed to exhibit superficial corrosion and be placed on grouted concrete masonry unit (CMU) blocks for base support. Other modifications include the incorporation of joist sisters to re-support the joists along the north wall due to moisture deterioration within their pockets (Figure 36). Along the eastern portions of the north and south wall, brick masonry piers and wood knee walls have been installed to improve the bearing of the joists in these areas, respectively (Figures 37 and 38). Along the south wall, the joists have been re-supported by a 10"x12" horizontal timber of the Hurst frame, however, of the seven vertical posts which support this timber, five have been lost or exhibit significant deterioration (Figure 39). RSA noted that the eastern canted column brace bears on a brick masonry pier (Figure 40), while the central and western canted column braces are currently supported by the lower horizontal timbers of the Hurst frame (Figure 41). These beams are exhibiting severe deterioration due to continued exposure to moisture over a long duration and are currently exhibiting crushing and looseness at their connections to the column braces (Figure 42) and other Hurst framing members (Figures 43, 44 and 45). RSA was able to move the western canted brace by hand.

**Figure 35:** First floor shoring within northern joist bay

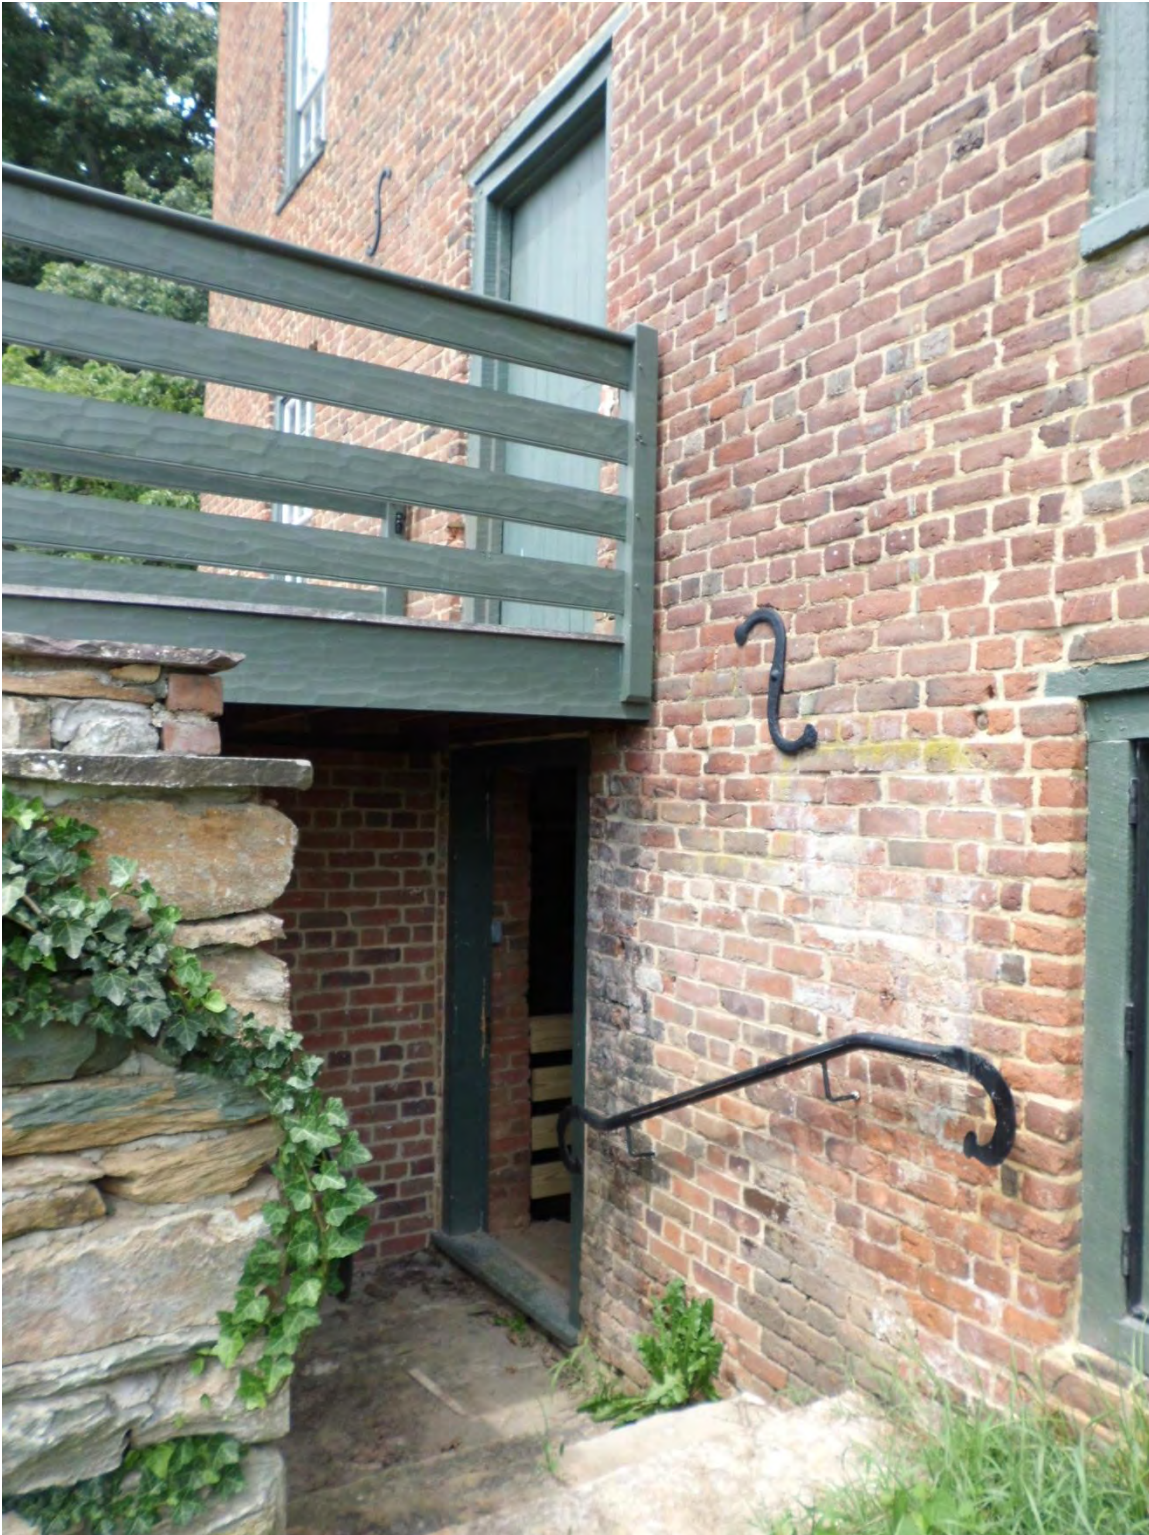
Additionally, a localized area at the west end of the mill building has been recently modified (2008) to promote circulation to the above-mentioned patio, to both the mill first floor and entry into the basement from the exterior. This work includes a new masonry opening within the mill's west foundation wall, a concrete areaway slab with CMU retaining walls, and new wood framed stairs (Figure 50). In conjunction with this latest construction, new shoring was installed to support the central bay of the first floor framing along the west wall.

**Figure 50:** Installation of new first floor and basement entry along west wall

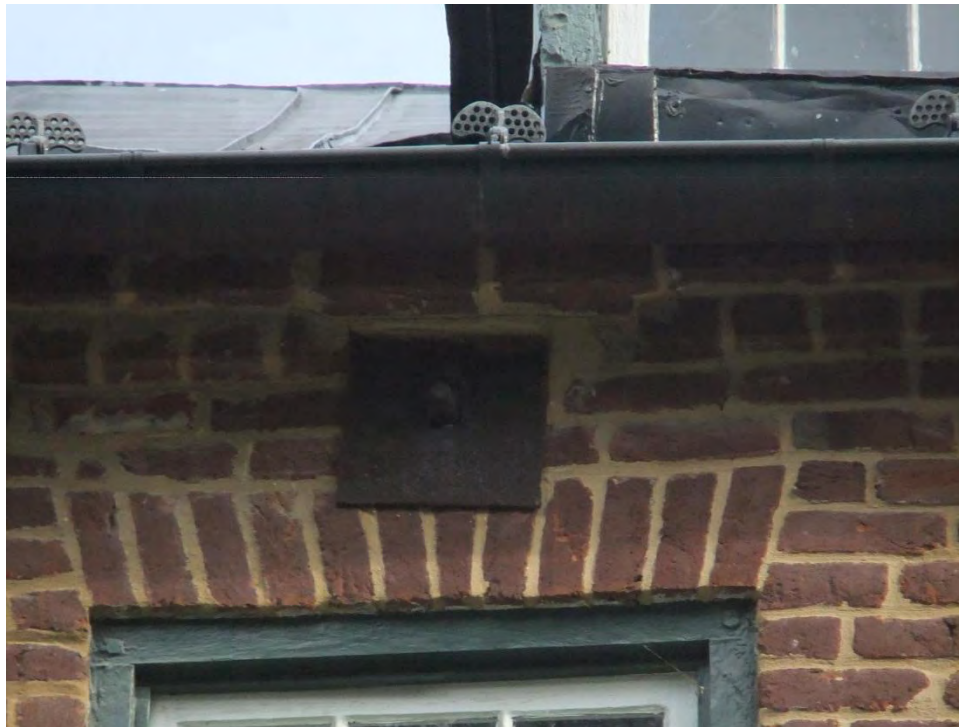
Similar to above, three additional wall ties were installed below the attic floor level to brace the south wall for out-of-plane displacement and buckling in 1948 (Figure 54). It would appear that these were added as a result of continued movement at the center bays of the south wall. While the center tie rod spans from the center of the north and south walls, the tie rods at each end of the north exterior wall span diagonally to the center of the south wall. Hence similar to above, the ties at the ends of the walls help to restrain the south walls out-of-plane movement by transferring these forces to the gabled-end walls. While the central tie rod is less effective it does serve in tying the roof thrust between the south and north walls. Along the north wall, the ties are anchored with the use of three rectangular wall plates while at the south wall the ties are anchored to a single wall plate above the central window of the third floor below.

**Figure 54:** 20<sup>th</sup> century tie rod anchorage below attic level
